## The October 23, 2011 Van, Turkey Earthquake ( $M_w=7.2$ )

### EARTHQUAKE DAMAGE

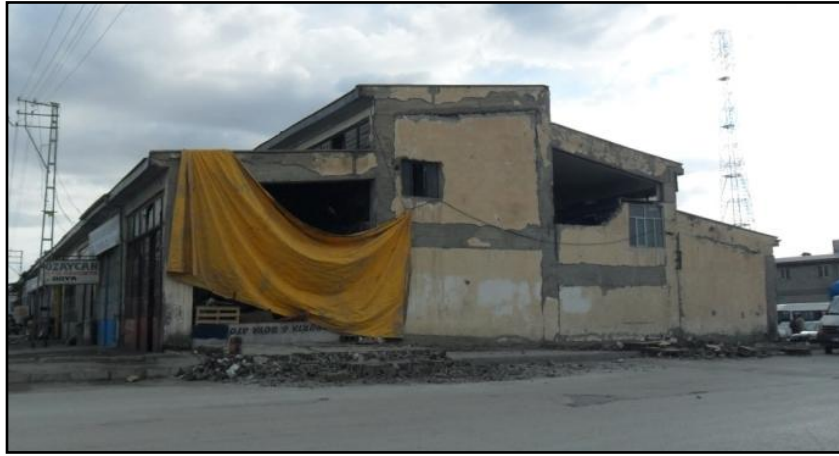
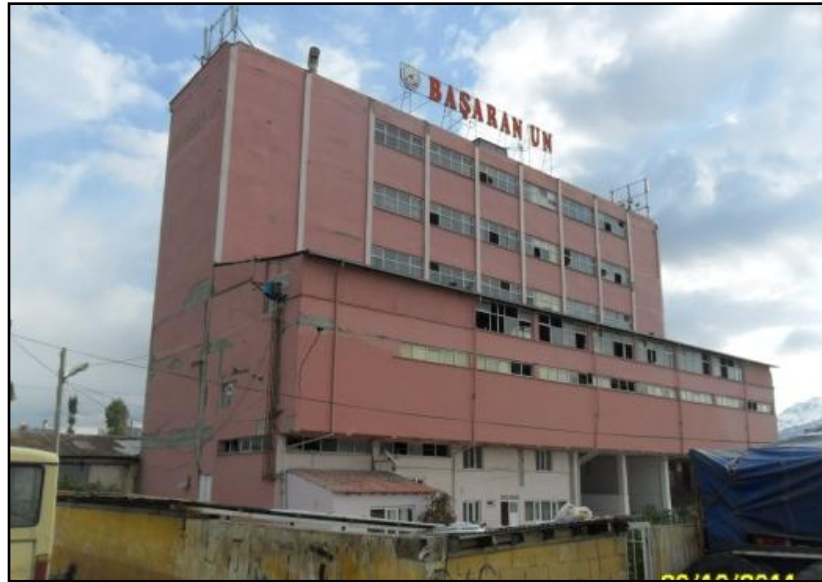
Most of the building damage in zone 1 was limited to damage of the partition walls (Figure 6) . No significant damage was observed in the new section (zone 2). Most of the damage concentrated in the main industrial zone (3) where most of the critical facilities and storage units are located. The main cause of damage was ground shaking. No damage was observed due to geotechnical effects such as liquefaction or soil failure. Most of the small size facilities were not insured.

Figure 6. Damaged walls of a mechanic shops in zone 1 (top). Similar damage to a facility in zone 3 (bottom).

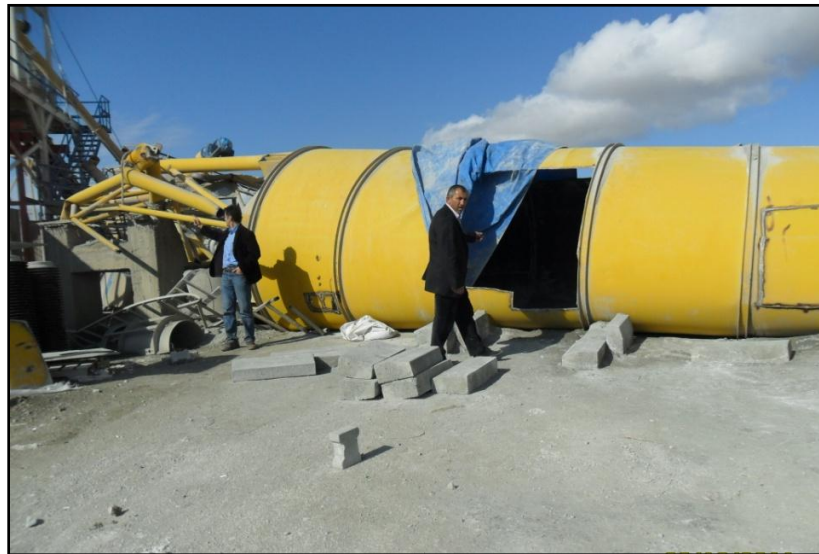
The heavy and slender, elevated steel cement silos collapsed due to improper detailing/dimensioning or suffered from inadequate seating width of the supporting concrete (Figures 7-9.)

Figure 7. Collapsed cement silo in the Van Industrial Zone

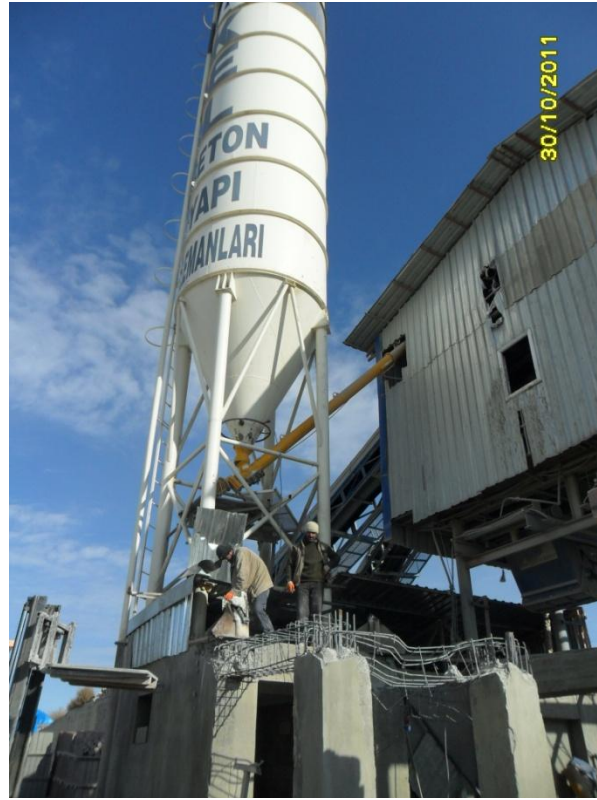
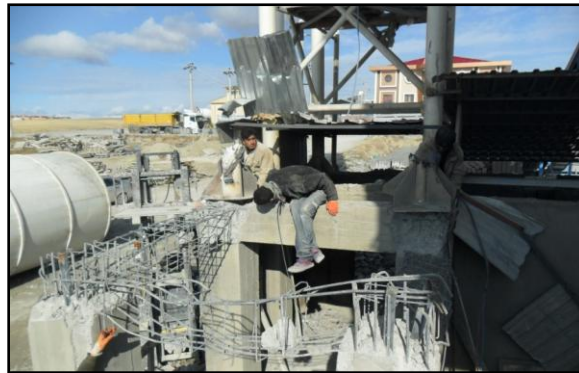
Figure 8. Damaged cement silo in Van Industrial Zone due to concrete crashing

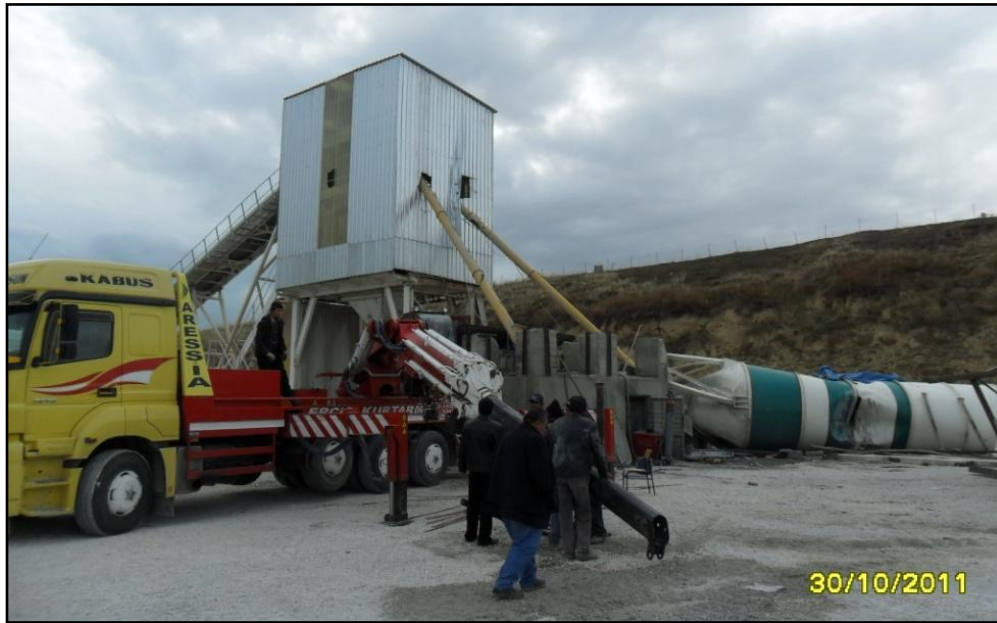
Figure 9. Collapsed silo on the Ercis-Patnos highway due to failure of the supporting concrete

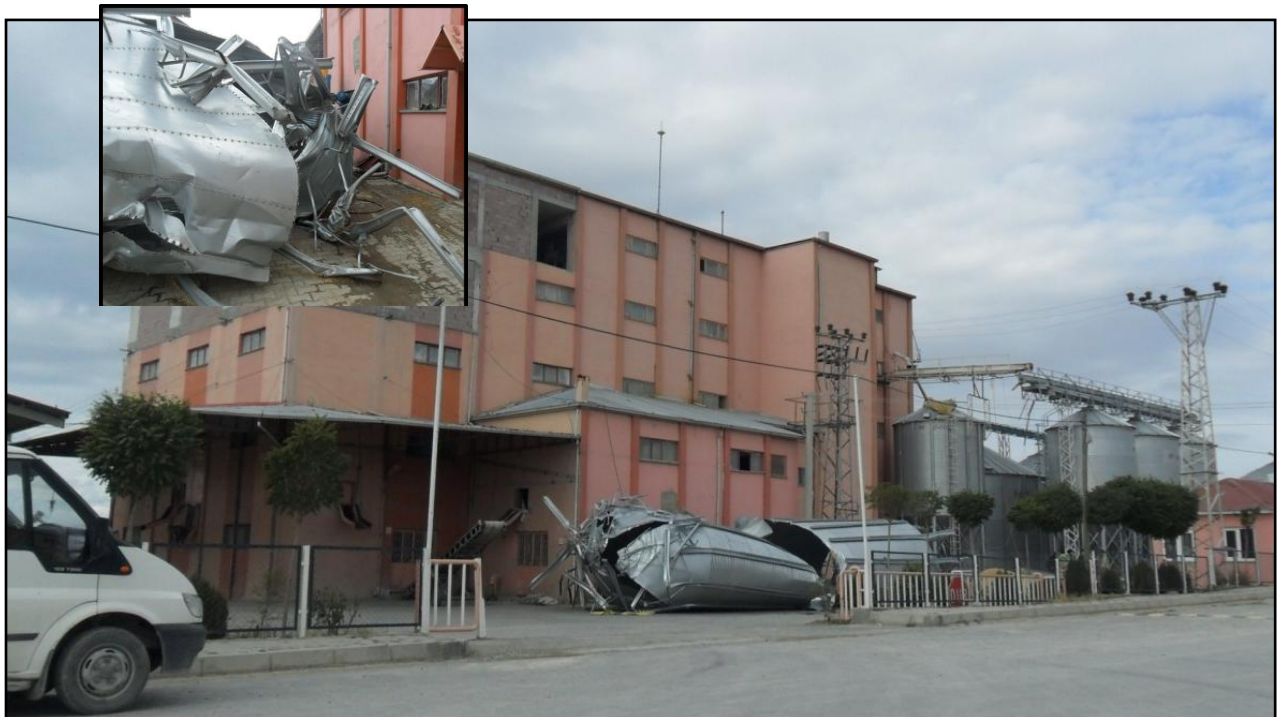
A number of wheat silos in Van Industrail Zone, collapsed due to inadequate dimensioning (Figures 10 and 11).

Figure 10. Collapse of the elevated wheat silos (Facility 1) due to inadequate dimensioning, Van

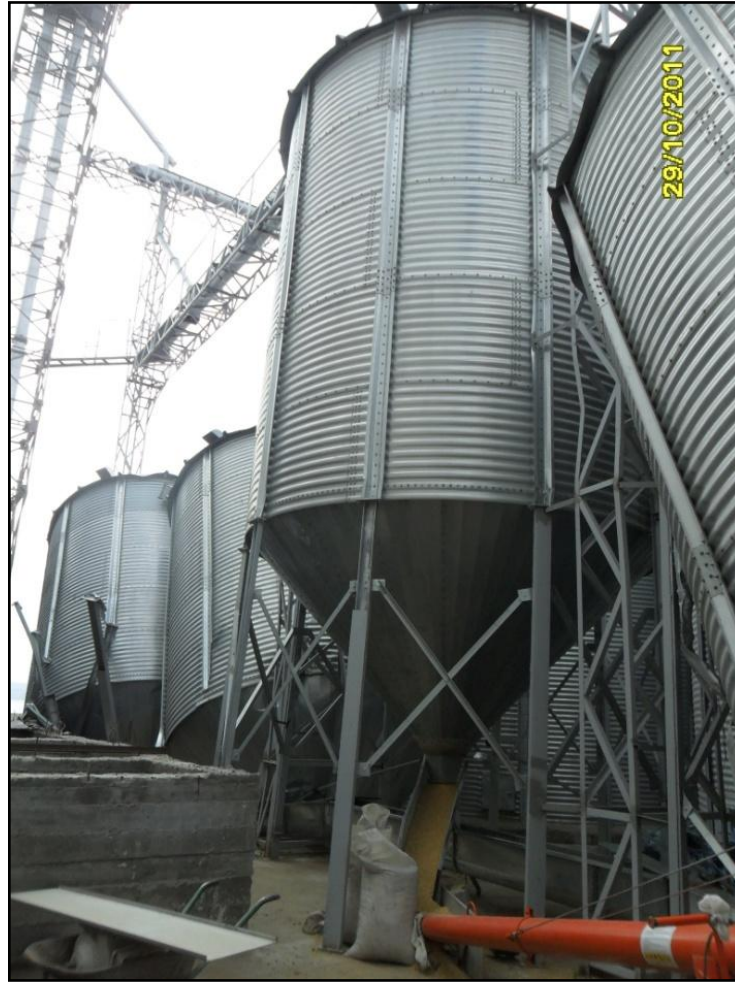
Figure 11. Collapse of the elevated wheat silos (Facility 2) , Van

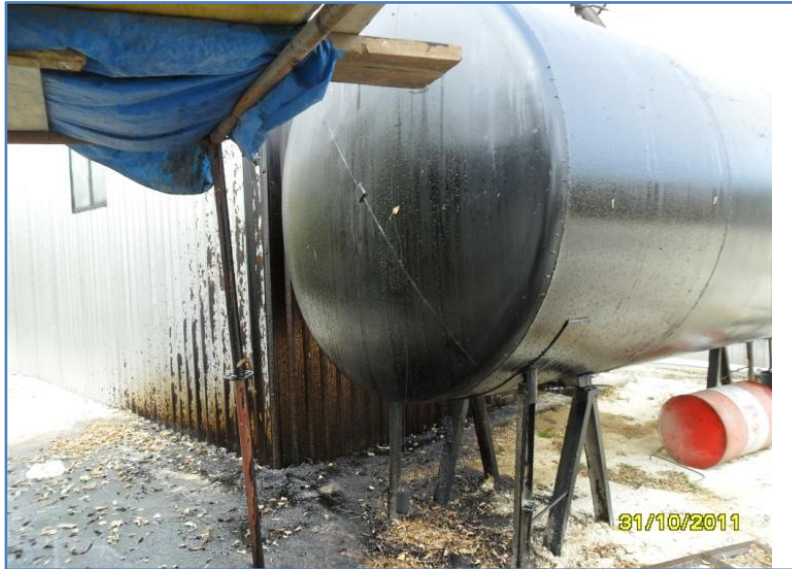
Tank damage was minimal. Some amount of deformation was observed at the weak supports of a small elevated fuel oil tanks in Ercis. Small amount of liquid overflow due to insufficient free board was observed. Similar problems occurred in some larger size other tanks in the surroundings of Erciş (Figure 12 and 13).

Figure 12. Overflow of liquid at elevated fuel oil tank (Ercis)

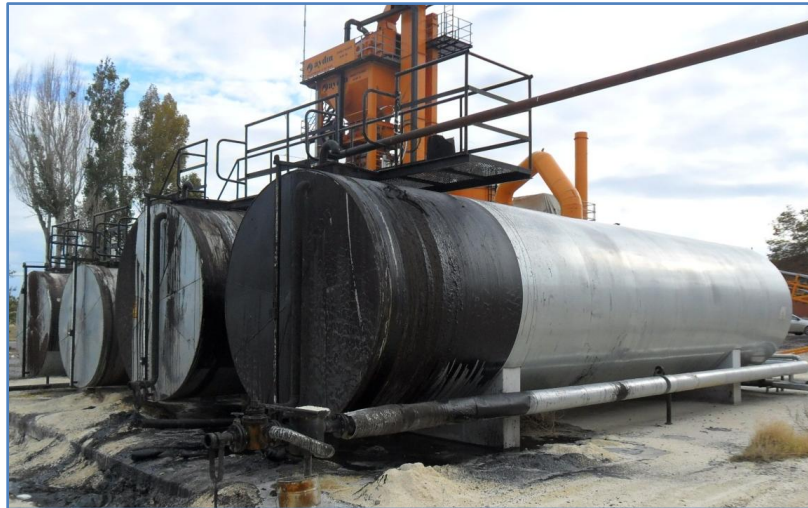
Figure 13. Overflow of asphalt in storage tanks (Ercis-Adil Cevaz highway)

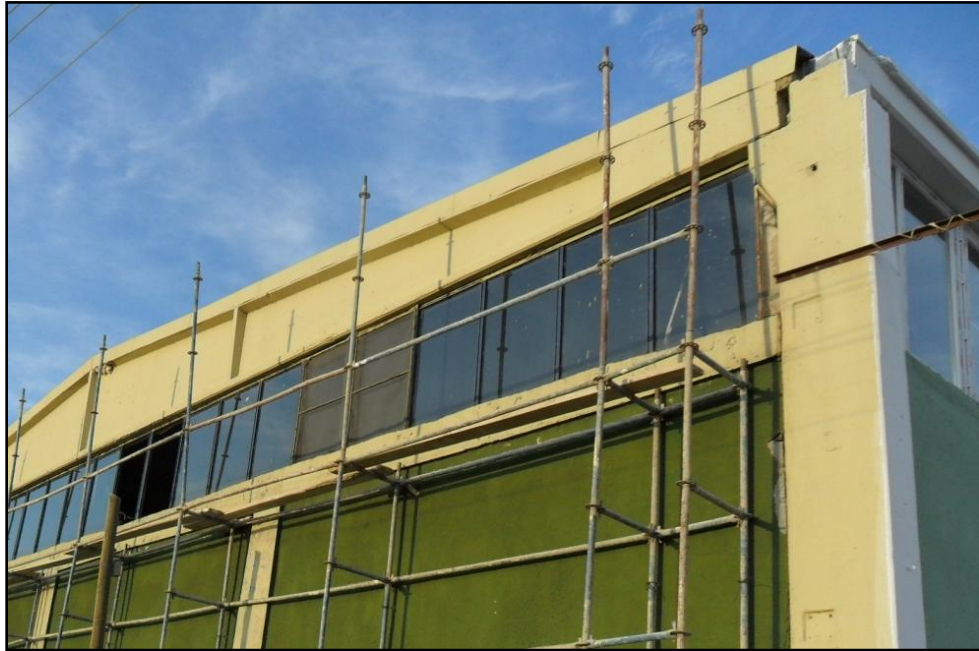
The heavy precast-concrete frames with precast roof beams suffered from connection problems. Noticable movements were observed at the beam- column connections (Figure 14) of the structures located around the Van-Ercis highway. More severe cases were observed at the Industrial zone of Van. The beams slipped-off from their seats because of inadequate steel-concrete bondage (Figures 15-17). Precast-concrete beams collapsed because of inadequate anchorage at the column –beam connections (Figure 17), at the top. Also column bending cracks occurred at the bottom of columns (Figure 18).

Figure 14. Joint separation in prefabricated structures

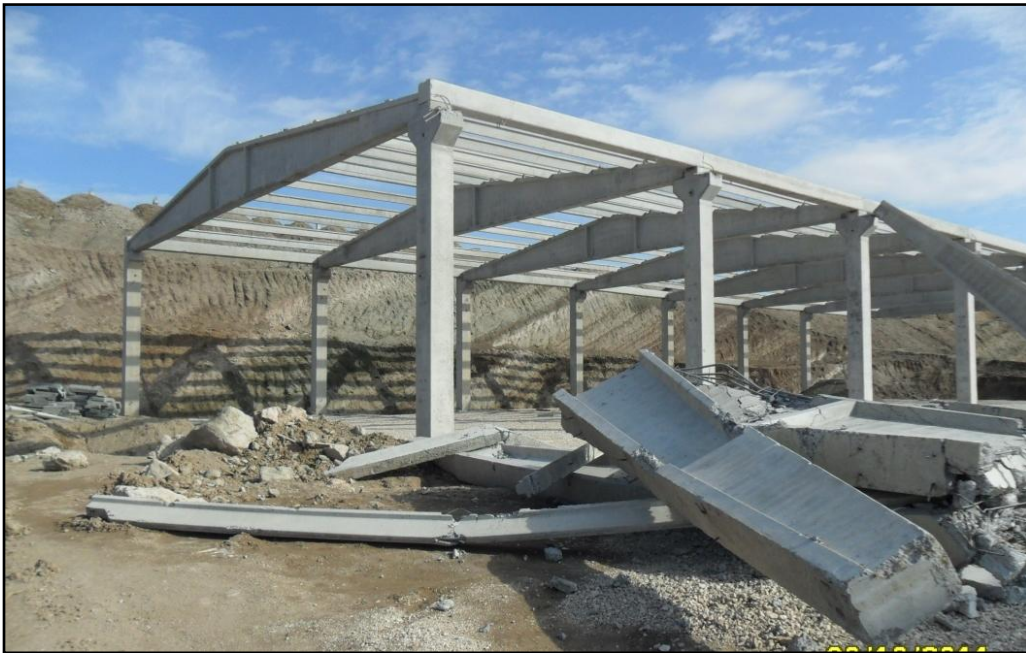
Figure 15. Collapsed prefabricated structure in Van Industrial zone (Facility 1)

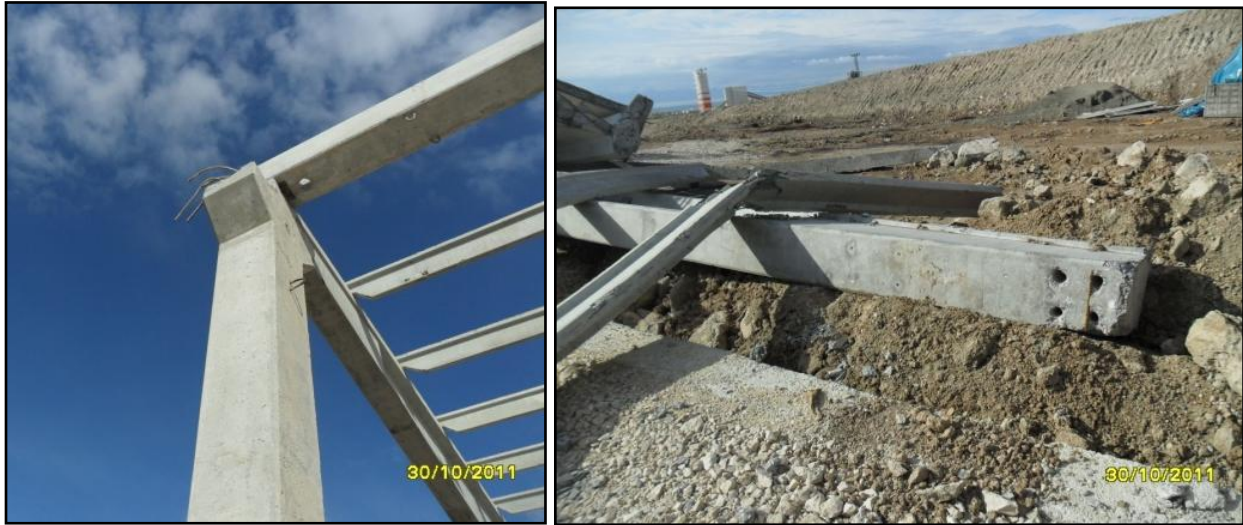
Figure 16. Failure of precast beams due to weak connection and lack of steel bondage

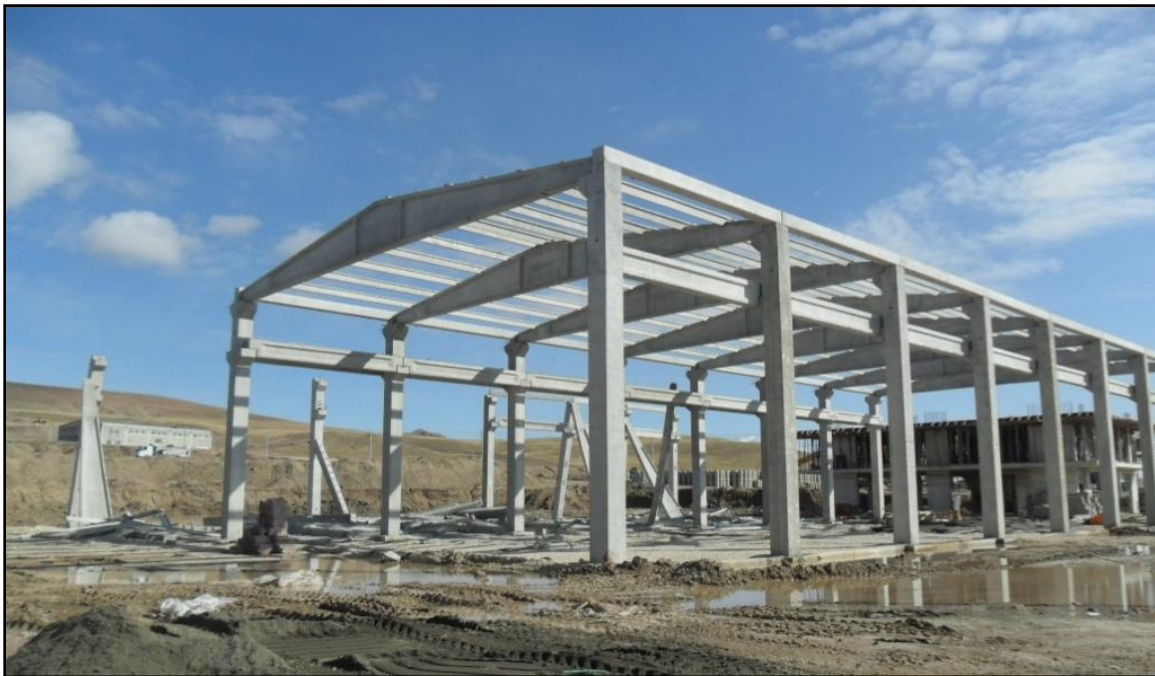
Figure 17. Collapsed prefabricated structure in new construction in Van

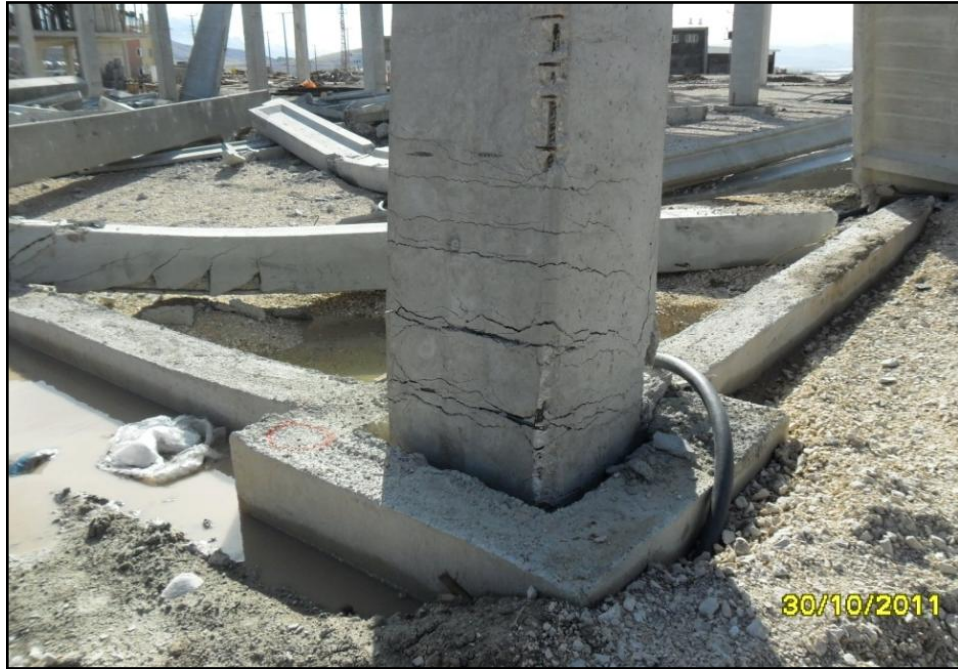
Figure 18. Cantilever column bending cracks at the base

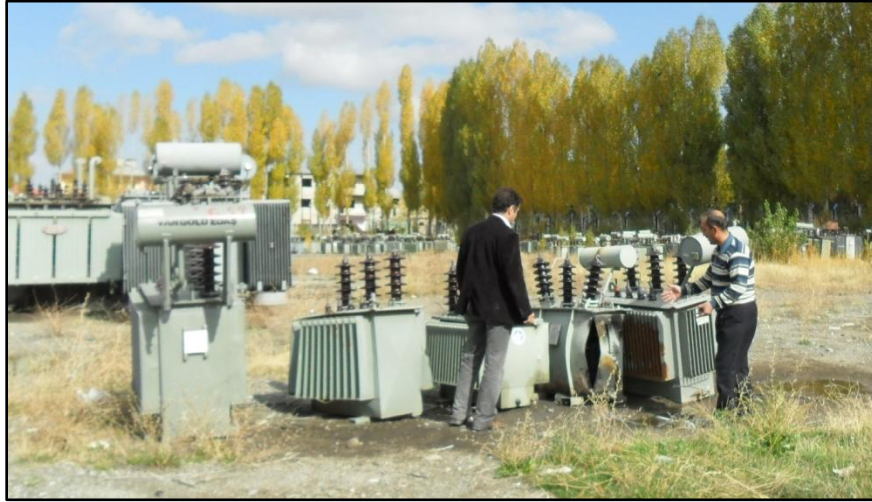
In Van, the electricity was shut down immediately after the earthquake for safety purposes. Two hours later, it was provided gradually in order not to cause any harm to people. In the second day, 70% of the city started receiving electricity. In the third day temporary housing units received electricity. Elevated transformers located at the balconies of flexible towers were particularly vulnerable to ground shaking. Brittle bushings were crashed because of the fall of building elements on to the interconnected cables between the transformers and buildings. A total of seven transformers (6x400kW and 1x600 kW) were damaged, burned or broken. Images of damage are provided in Figures 19 and 20).

Figure 19. Burned/damaged 400 kW and 600 kW transformers due to fall from elevated locations

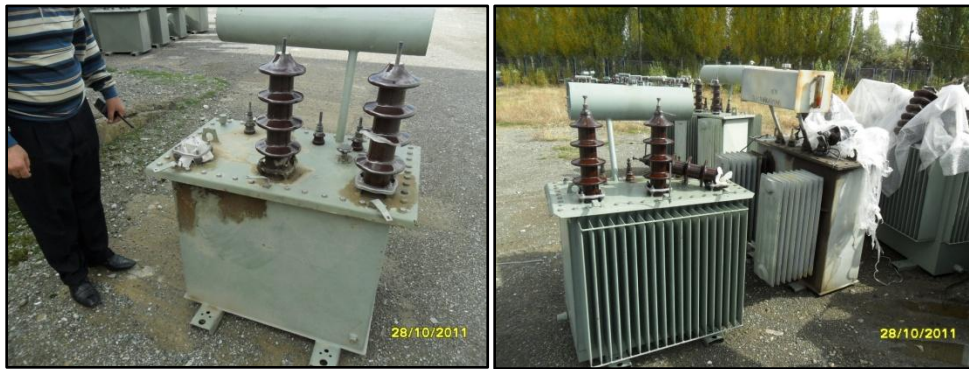
Figure 20. Damage to brittle bushings due to fall of building elements onto the interconnecting cables

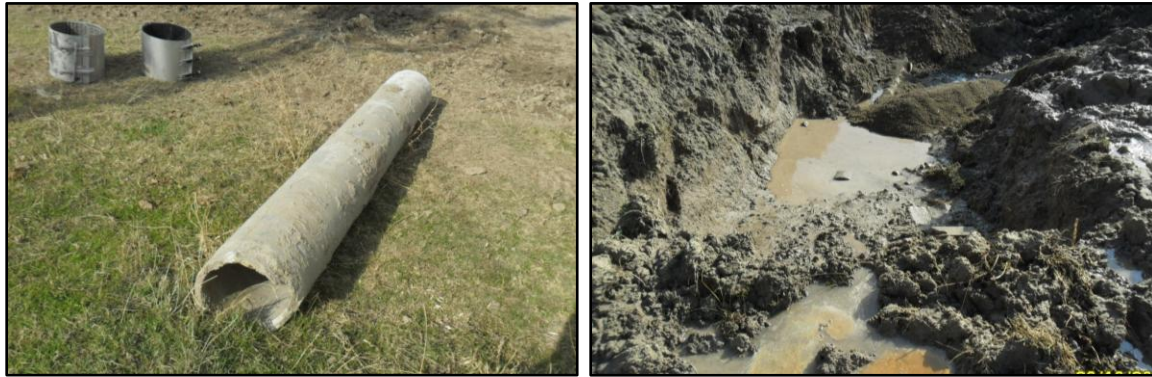
No damage to water supply and sewage systems was reported in Van. The water supply was uninterrupted. However, pipe breaks occurred outside the city. The water transmission line of 100. Yıl University had pipe breaks at many locations due to soil liquefaction and settlement/land slide (Figure 21). There was a number of pipe breaks in the transmission line from the source to the city. Many pipes had to be repaired in order to provide water to the surrounding villages and to temporary accommodations.

Figure 21. Pipe breaks and repaired sections in Topakca village due to liquefaction induced lateral spreading

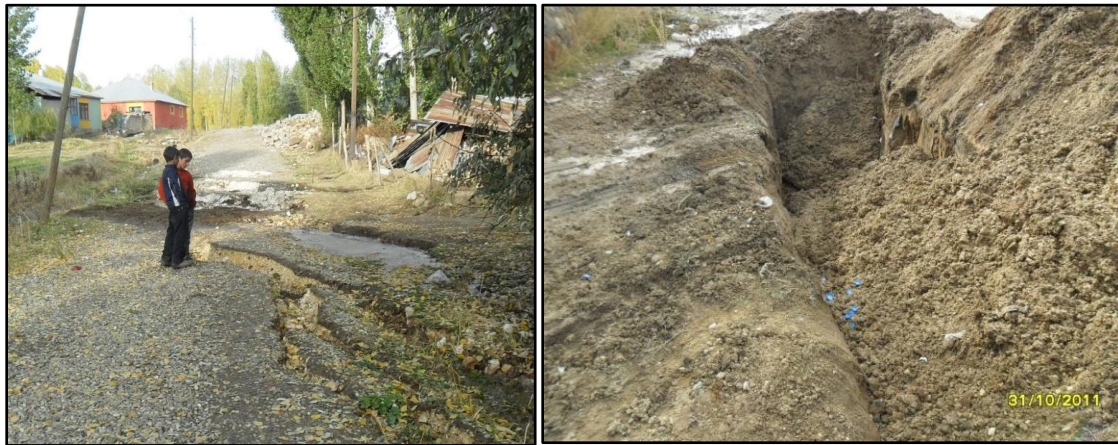
In Ercis, water distribution interrupted for a couple of days due to pipe breaks in the main system. This created a problem due to negative pressure in the system. There were also some

localized damages in Celebibağ region (Figure 22). However after minor repairs and reconfigurations all services were fully functional.

Figure 22. Pipe crash and pullouts and repaired pipes in Celebibağ , Ercis

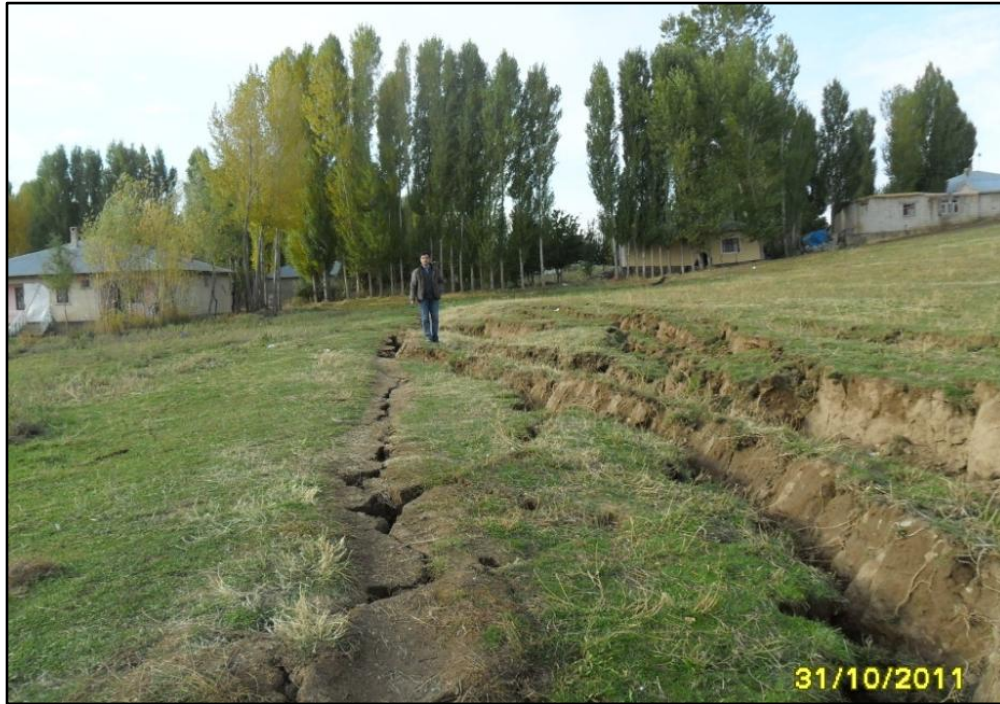
In Çelebibag (Western Ercis near the Erciş-Patnos highway), land slide induced lateral spreading and settlement was observed in weak soils. Permanent ground deformations reached 50 cm in the horizontal and vertical directions. Water transmission/distribution in the vicinity of tension zones were damaged. The damage was repaired immediately after the earthquake (Figure 23).

Figure 23. Soil cracks due to land slide in Celebibag, Ercis

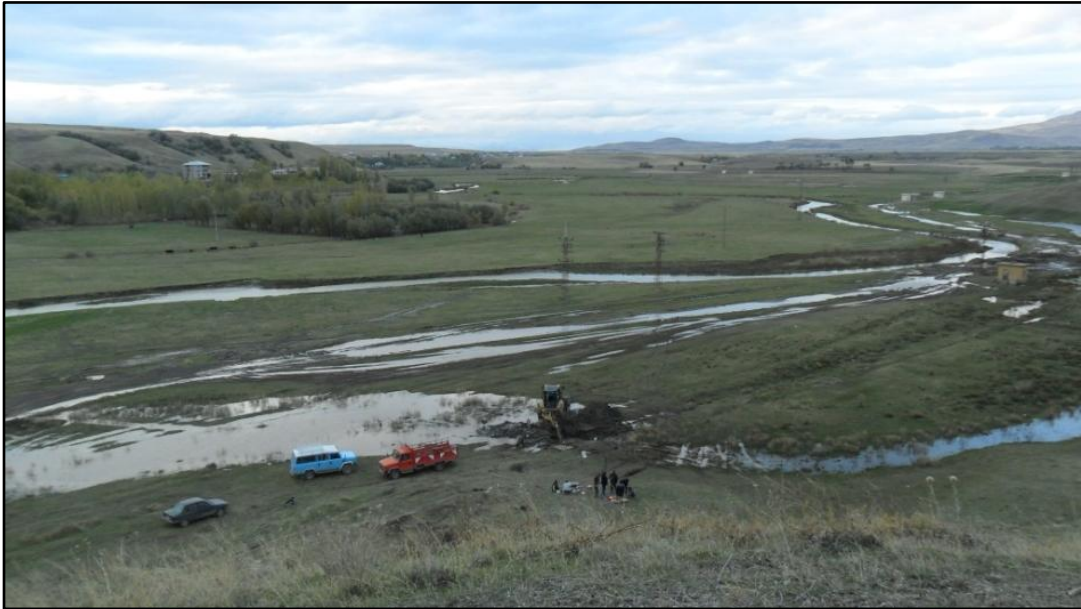
In Van, extensive liquefaction induced lateral spreading, settlement and rock falls took place near the village Topakca, next to the river in Northern Van, 6 km's to the northwest of the 100. Yıl University (Figures 24- 28).

Figure 24. Liquefaction and settlement zone near Topakca village, Northern Van

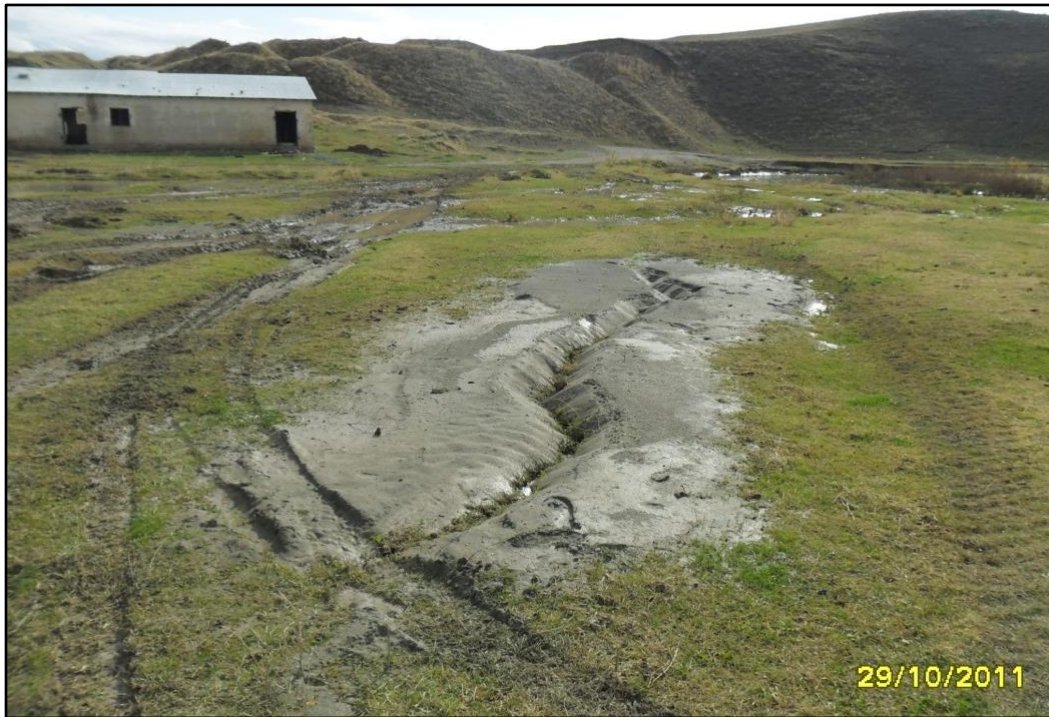
Figure 25. Sand boils due to liquefaction in Topakca (Mermit) village, Van

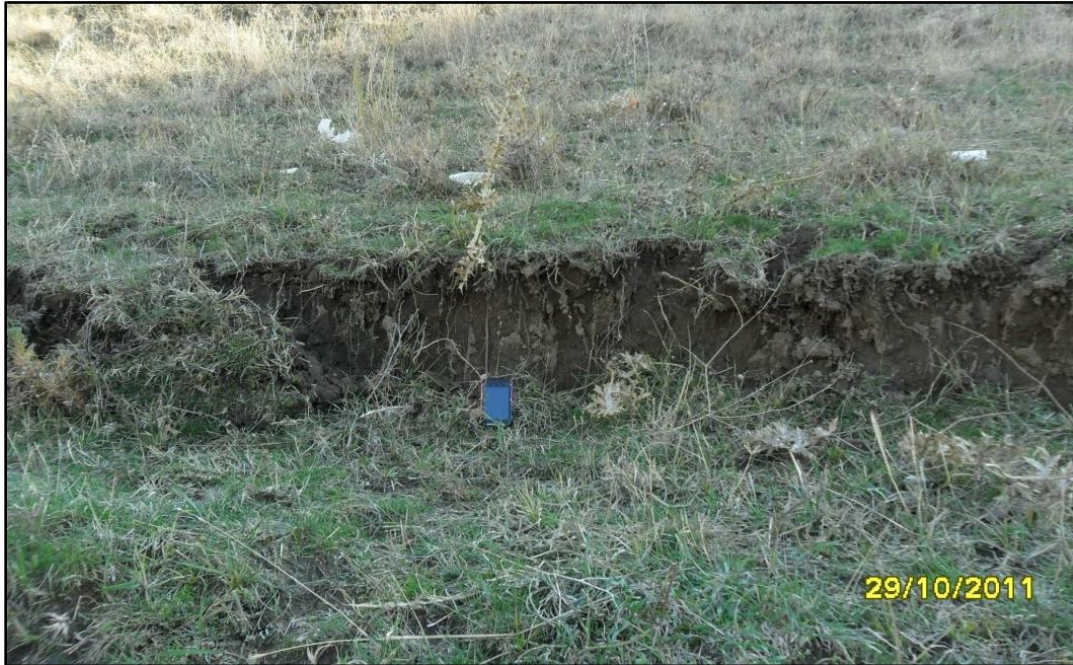
Figure 26. Overall basin settlement (upto 50cm) in the village Topakca

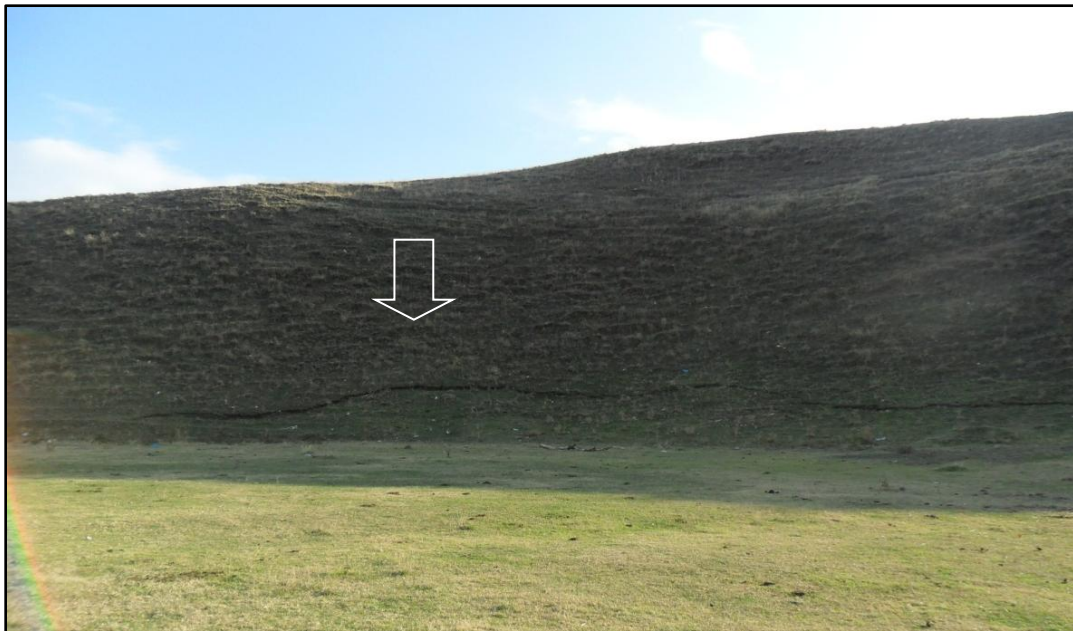
Figure 27. Overall basin settlement nearby the Topaktas village

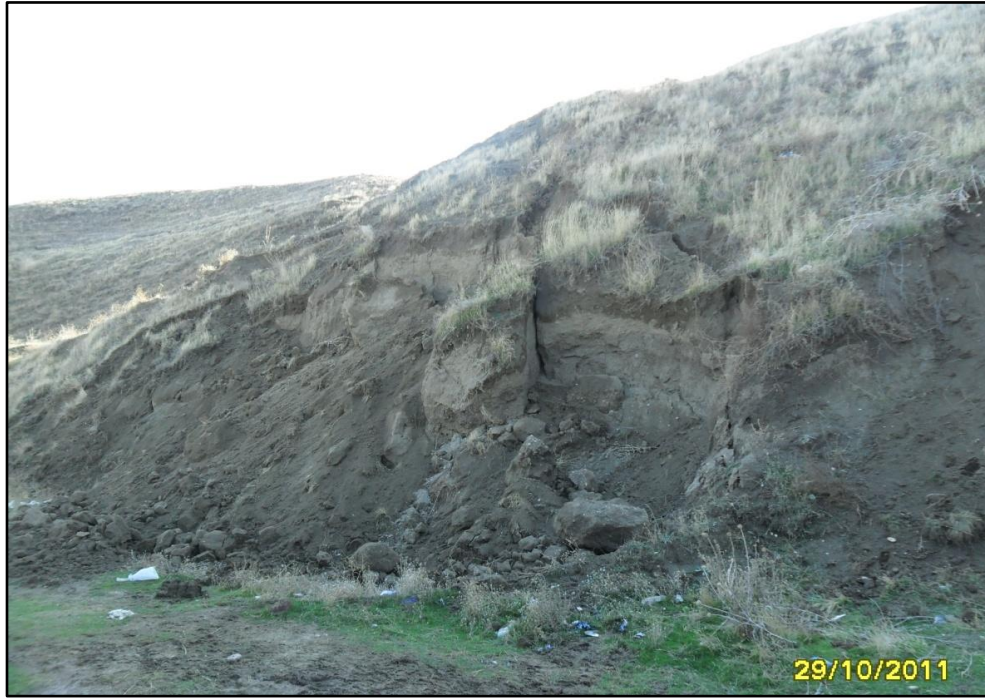
Figure 28. Rockfall in Topaktas (Mermit) village behind the damaged house
