REPORT ON 1999 KOCAELI AND DÜZCE (TURKEY) EARTHQUAKES

MUSTAFA ERDIK

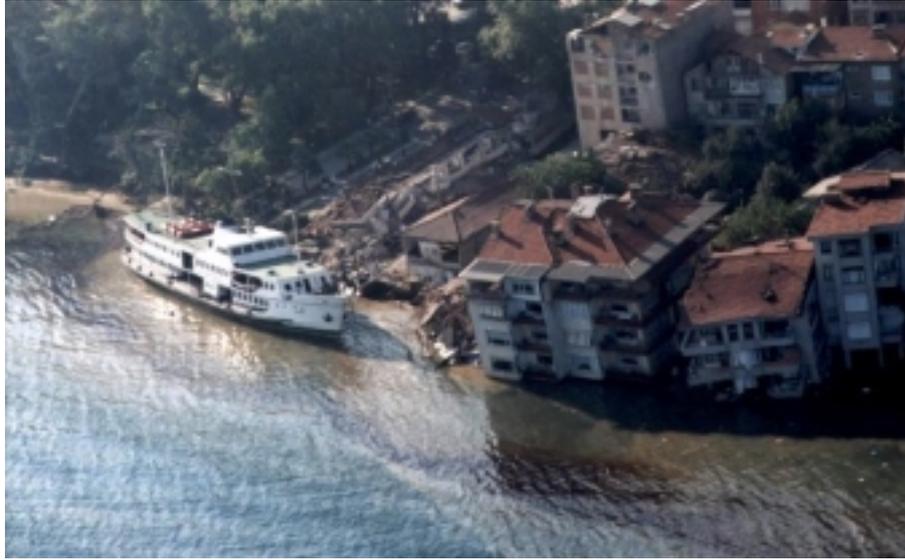
Figure 7. Ferry Boat in Izmit Gulf thrown to shore due to strong wave action

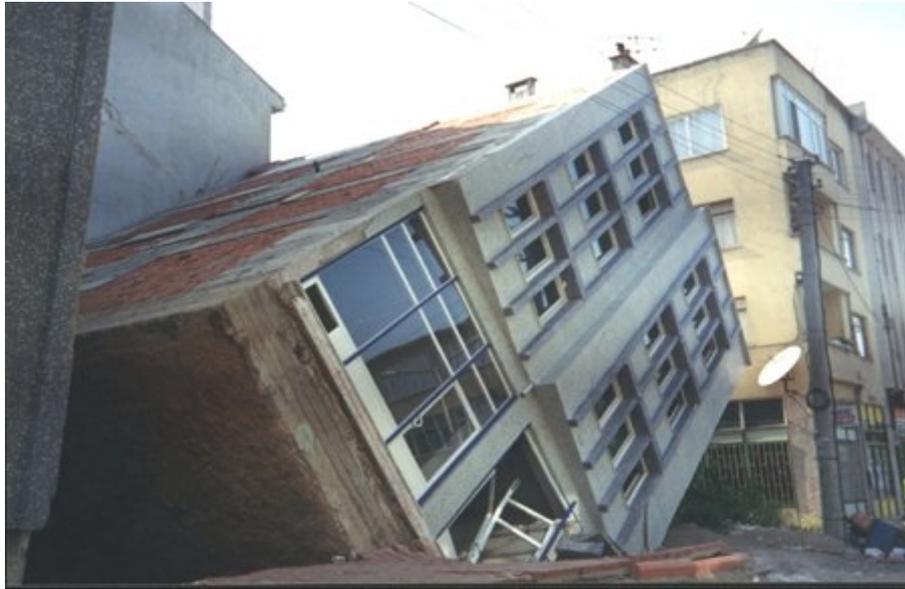
In Adapazari, located over young riverbed sediments with soft and liquefiable silts and sands, hundreds of buildings sank, as much as 1.5m, or tilted due to shear failure of the foundation media and liquefaction (Figure 12). Surface manifestations of liquefaction in Adapazari and Sapanca included sand boils and lateral spreading. Buildings punched down into the soil softened by the shaking and high numbers of oscillation cycles, which lifted up the sidewalks due to the injection of soil material (Figure 13). However the softened and/or liquefied soil media also acted as an isolator dissipating the energy at the foundation level and avoiding shaking damage to the buildings.

Figure 12. Overtumed buiding in Adapazari due to weakened/liquefied foundation

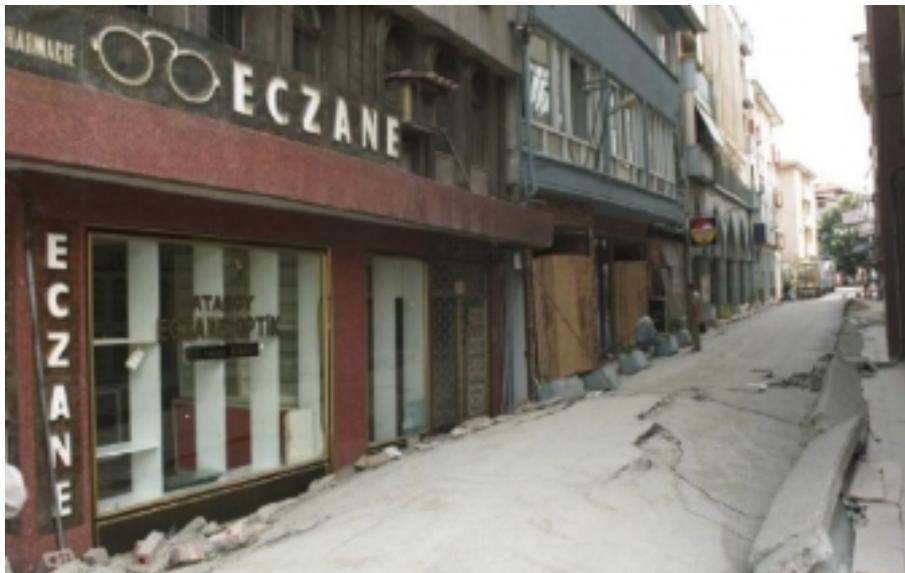
Figure 13. Building in Adapazari that sank into the ground and the displaced soil heaved

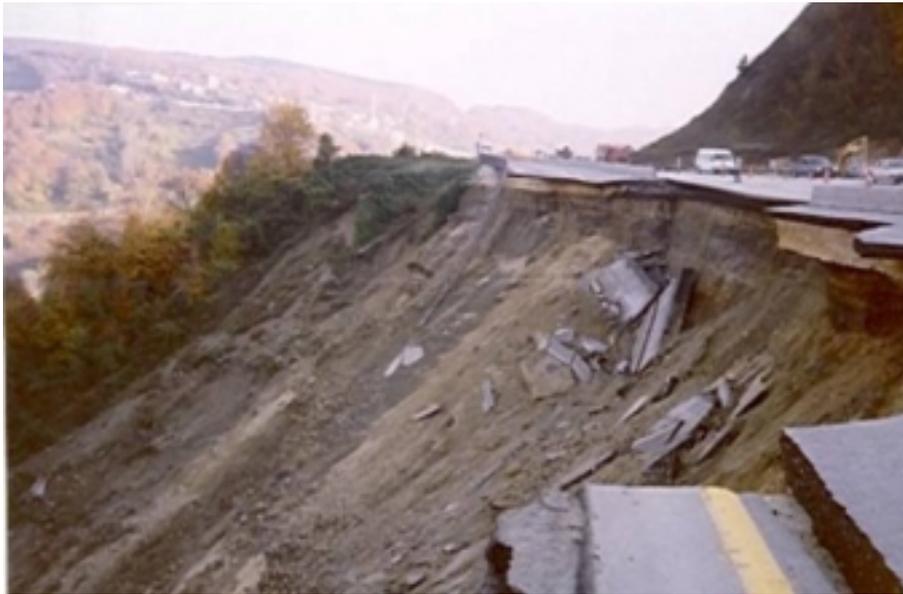
Only limited slope failure, mostly in the form of road embankment failures was observed in both events. The only major landslide took place on west bound lane of E-5 highway at Bakacak in Duzce earthquake which disrupted the traffic for several days until a bypass road was constructed (Figure 14). The landslide occurred on the natural slope and in the highly weathered parts of the rock.

Figure 14. Landslide on E5 Highway in Duzce Earthquake

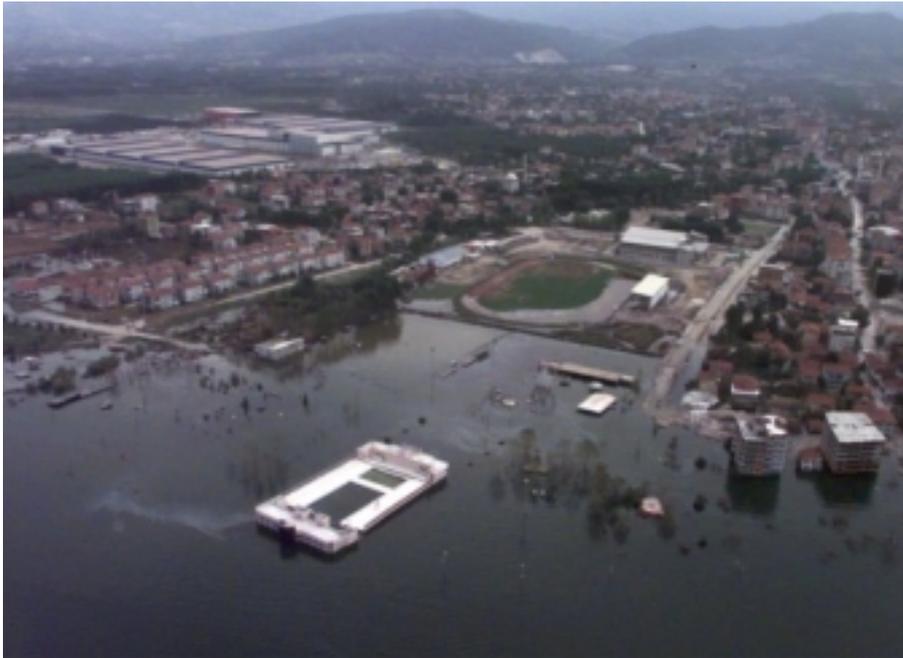
In the eastern part of Gölcük, a broad regional subsidence occurred affecting the Ford Factory under construction and several urban settlements (Figure 15). The subsidence is believed to be the result of a graben-like action associated with a local pull-apart tectonic structure. The subsidence caused a 4-km-long section of the coast near Gölcük to submerge about 3 m.

Figure 15. Subsidence at Golcuk along the southern shore of the Izmit Bay

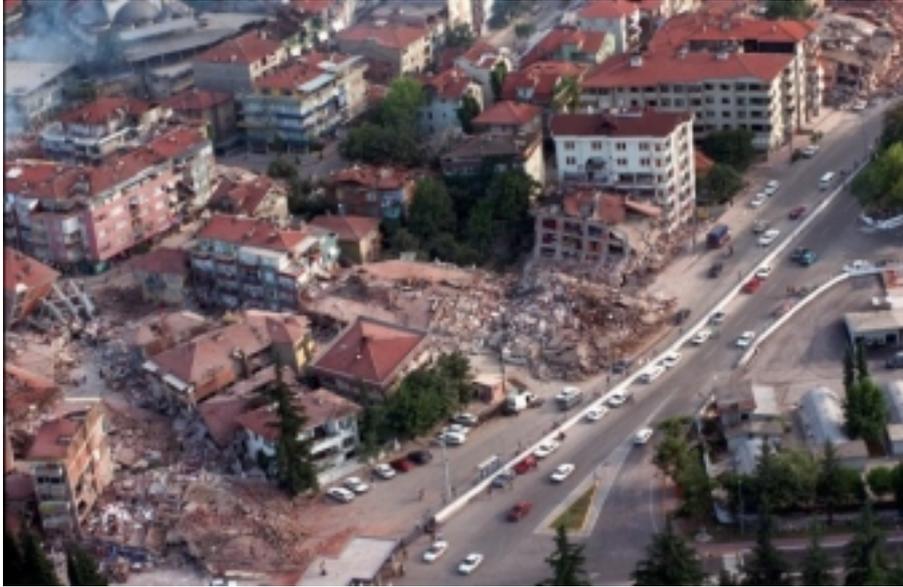
Figure 16. A general view of building damage in Golcuk

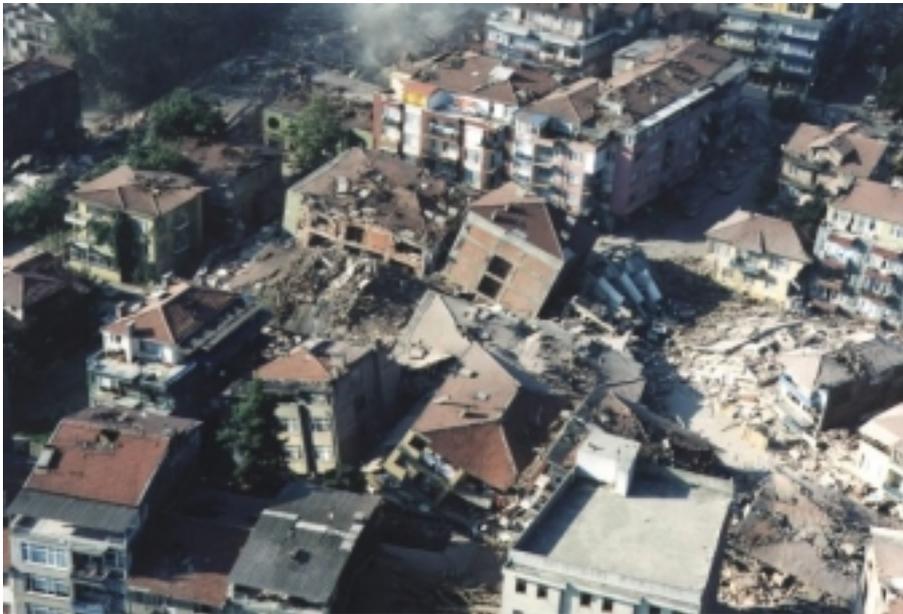
Figure 17. A general view of building damage in Duzce

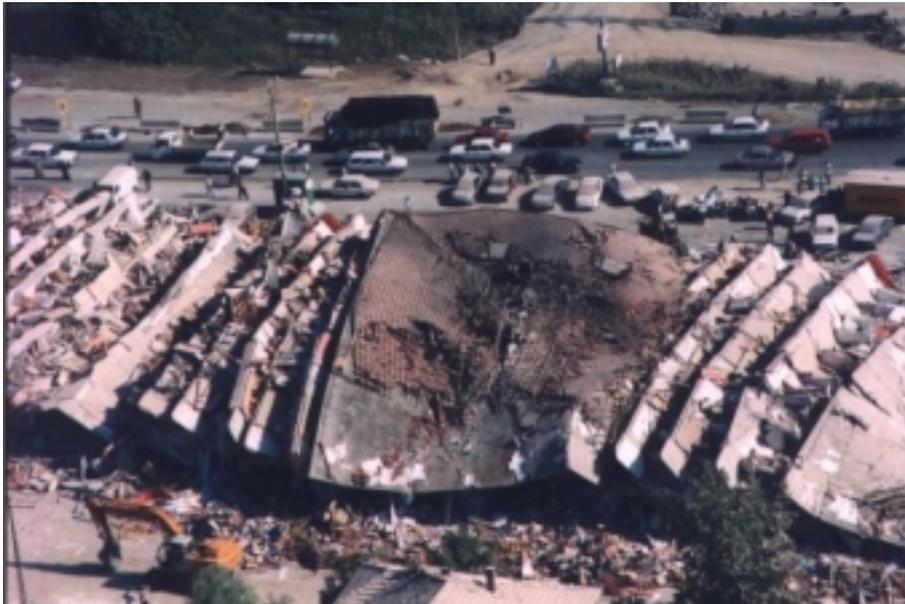
Figure 18. A “pancake” type collapse in Kocaeli Earthquake

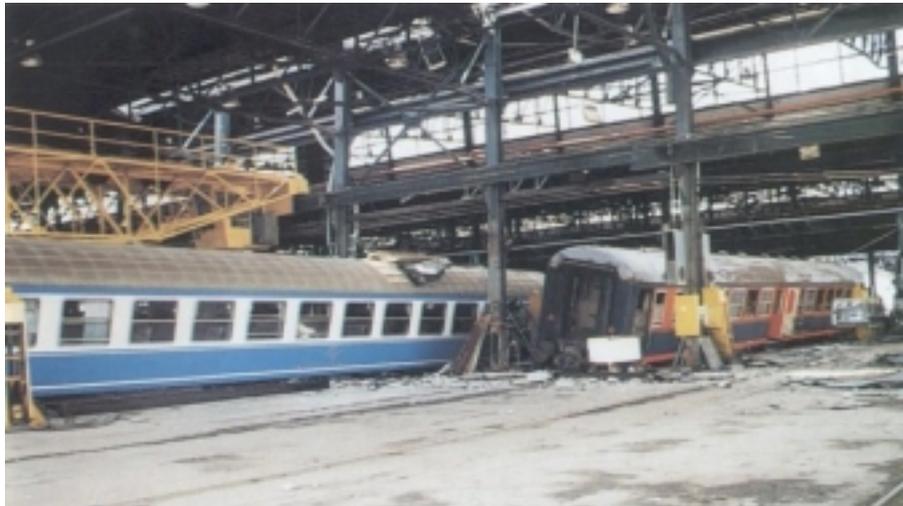
Figure 21. Damage at TUVESAS rail car factory (steel building) in Adapazari

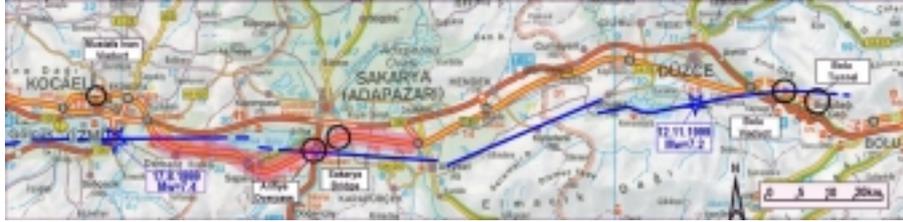
Figure 22. General view of highway and viaduct damages in Kocaeli and Duzce Earthquakes

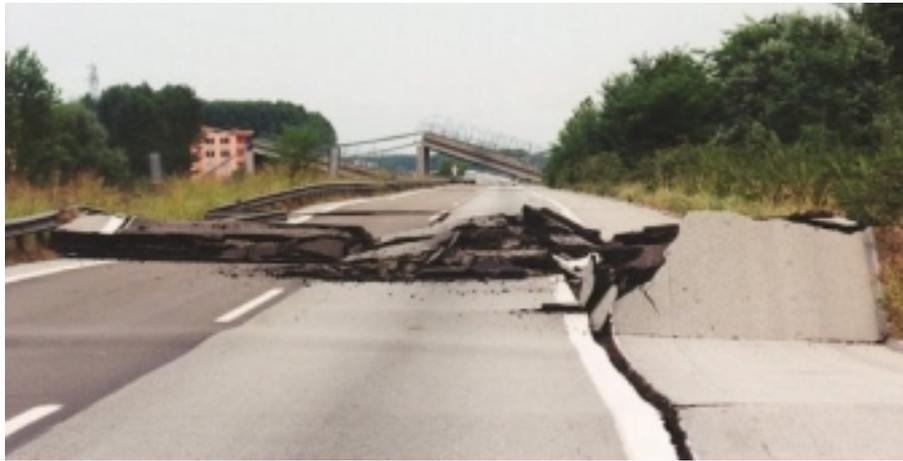
parallel to the fault rupture at a less than 3km distance. The damage was in the form of surface ruptures (both tension and compression cracking) and settlement of roadway fills. Settlements ranging between 10 to 50cm were observed (Figure 23).

Figure 23. Damage to road surface on TEM Highway in Kocaeli Earthquake

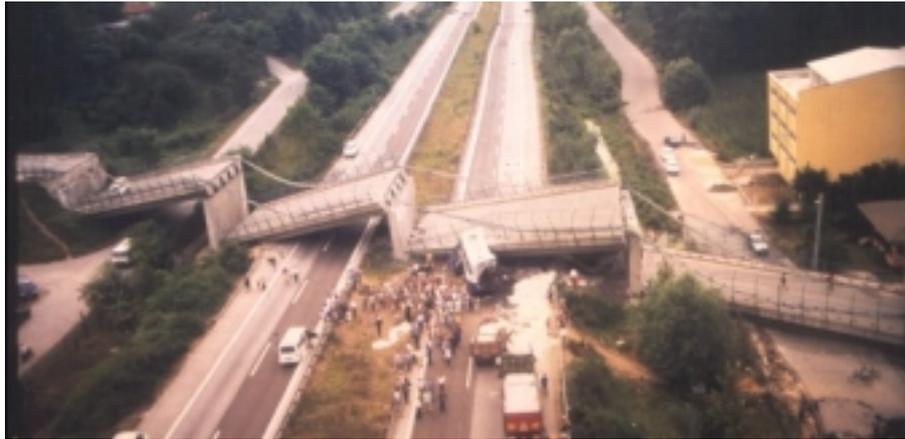
The most common types of damage to bridges and overpasses were displacements of girders at seating, shear key failures, and cover concrete spalling of deck around abutments. Several overpasses and viaducts on TEM sustained damage varying from limited shifting of girders from their seats (Mustafa Inan Viaduct), failure of shear keys and damage of elastomeric bearings (Sakarya River Bridge and D310 Overpass) to total collapse (Arifiye Overpass – D650). Location of these viaducts and bridges are shown in Figure 22. Sakarya River Bridge is located about 2km to the north of the fault. Most girders in the north lane are shifted off their seats as much as 0.5m as a result of the failure of shear keys. Most of the elastomeric bearing pads were dislocated and become dysfunctional. The fault rupture passes under the Arifiye Overpass with a right-lateral offset of 1.5m (Figure 24). The fault rupture passed between the northern abutment and the adjacent pier at

an angle of about 65 degrees with the bridge axis. As a result of this tectonic movement in excess of the seat width the girders were unseated in a consecutive manner and fell from their supports.

Figure 24. Collapse of the Arifiye overpass on TEM Highway in Kocaeli Earthquake.

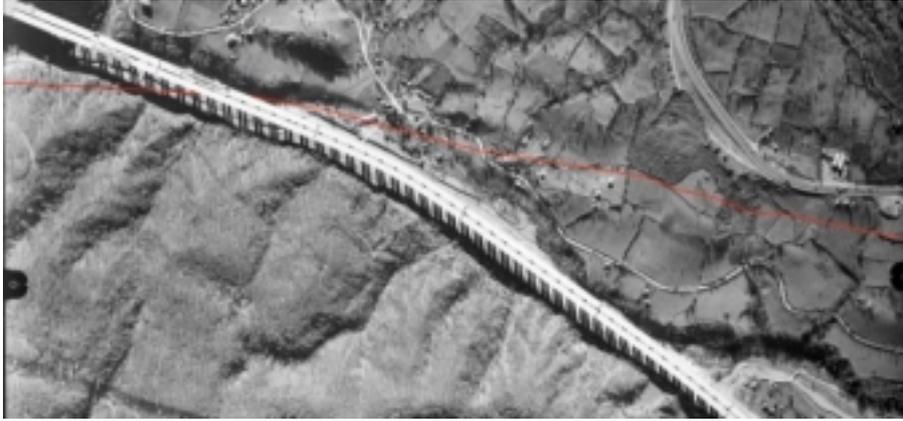
Figure 25. Aerial view of the Bolu 1 Viaduct. The fault rupture is indicated by the red line.

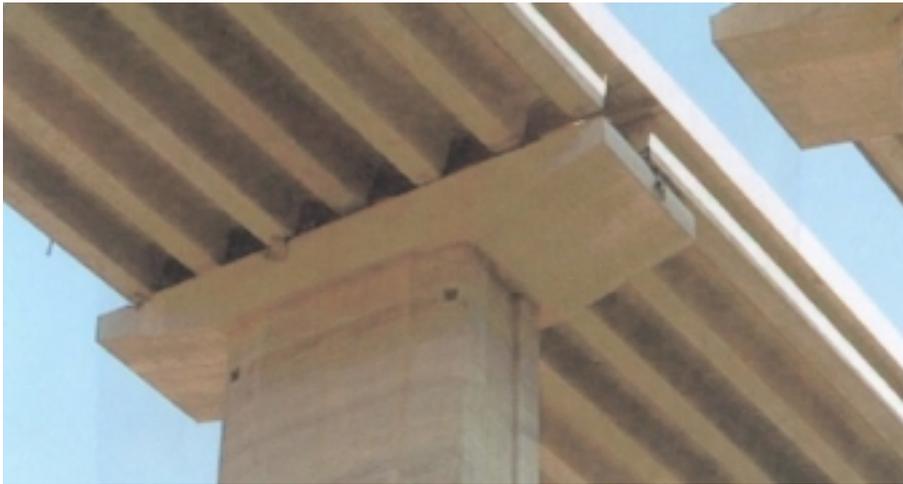
A section of the Trans-European Motorway (TEM) between Bolu and Düzce is under construction. The motorway follows the northern side of the Düzce basin from Gümüşova to the Asarsuyu portal of the Bolu Tunnels. Bolu Viaducts #1 and #2 (under construction), Bolu Bridge and Bolu Tunnel (under construction), located in the last segment of the TEM to be completed, were strongly affected by the earthquake. Bolu viaducts 1 and 2 carry a 6 km long section of the motorway with a maximum height of 49 m, span of 39m and a width of 17.5m. The piers are supported by 12 1.8m diameter piles. Bolu Viaduct #1, 2.3km long with dual 59 spans, was located directly on the fault rupture. The fault crossed the viaduct at Pier#46 at an angle of 20-30 degrees with the viaduct axis, with a right lateral offset of 2.5m, causing substantial shifts between the superstructure and the piers (Figure 25). Some piers rotated (about the vertical axis) by 13 degrees (Figure 26). Almost all the sliding elements at girder seats and the energy dissipating devices between spans became damaged or useless.

Figure 26. Movement between the piers and the girders of Bolu 1 Viaduct

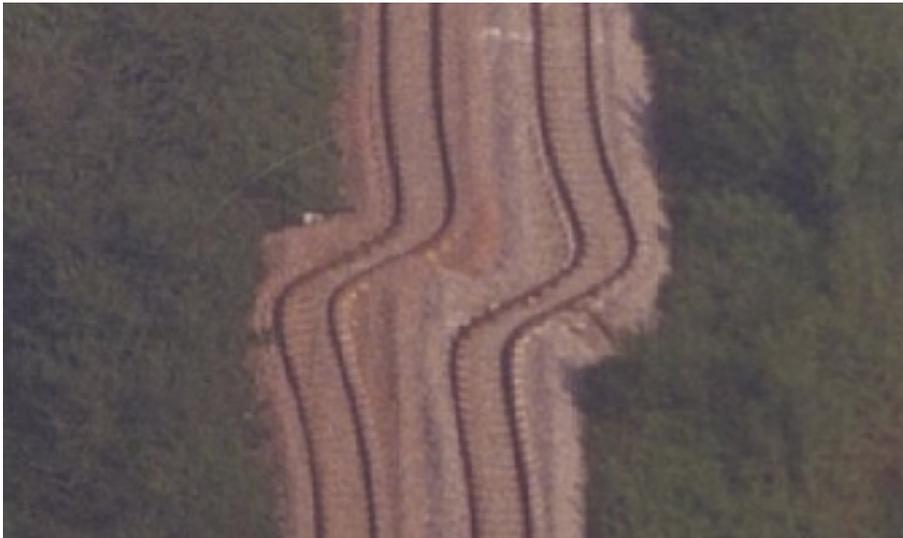
At the fault crossing near Arifiye, the tracks of the main railroad between Ankara and Istanbul were damaged. The tracks were distorted to an “S” shape by the fault offset at the Tepetarla station damaging about 200m section of the railroad. At

Figure 27. Bucking of the railroad track near Sapance in Kocaeli Earthquake

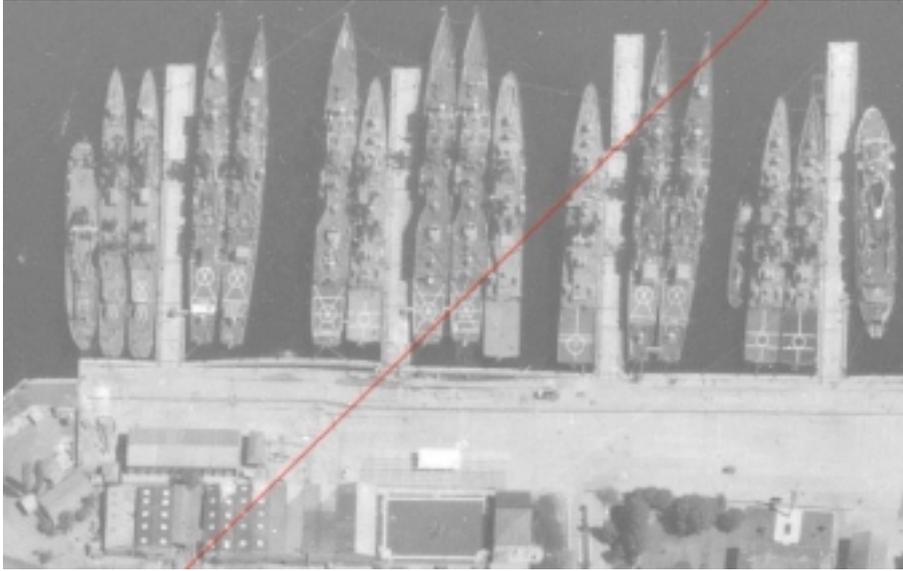
Figure 29. Aerial view of the Navy Base in Golcuk. The fault rupture is indicated by red line.

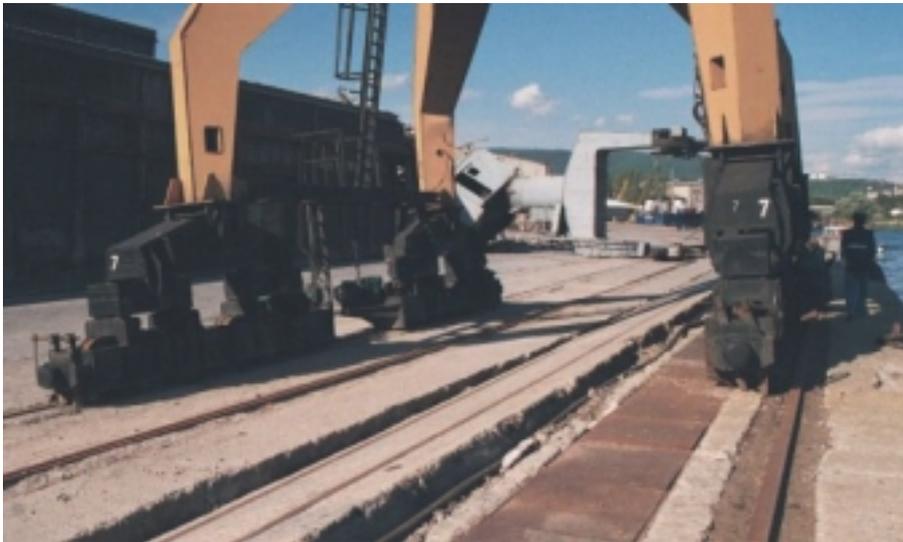
Figure 30. Damage at Derince Port in Kocaeli Earthquake

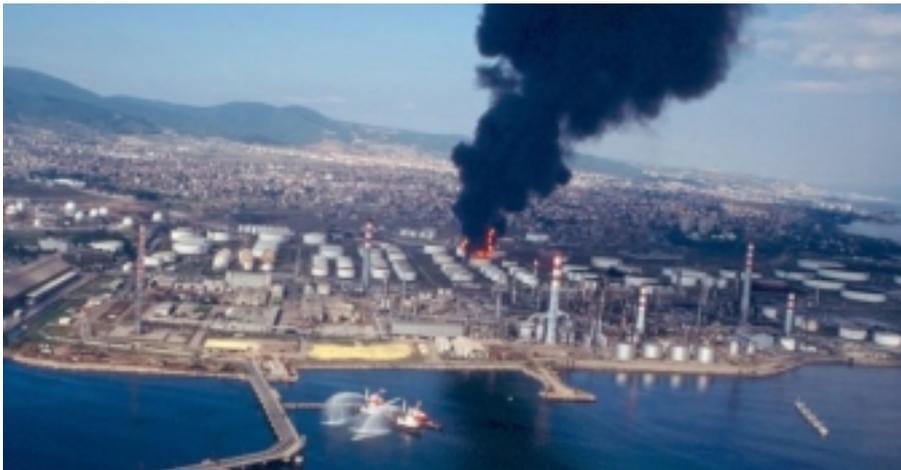
An extensive concentration of state-owned petrochemical complexes is located within 5km of the fault, including Tupras, Petkim and Igsas. The heaviest damage occurred at the Tupras facility, the largest refinery in the region producing about twelve million tons per year. The refinery was working at about 90 percent of its design capacity and can be considered a modern and efficient plant. The earthquake caused significant structural damages to the refinery itself and associated tank farm with crude oil and product jetties. The consequent fire in the refinery and tank farm caused extensive additional damage (Figure 31). Fire started in one of the Naphtha tanks continued for three days endangering the safety of the whole region. Six tanks of varying sizes in the tank farm of 112 tanks were damaged due to ground shaking and fire (Figure 32). There were damage to cooling towers and the port area. Collapse of a 150m high heater stack on the boiler and crude oil processing unit caused significant damage and started a second fire. The total damage is estimated to be around US\$350 million.

Figure31 A helicopter view of the fire in Tupras petrochemical complex.

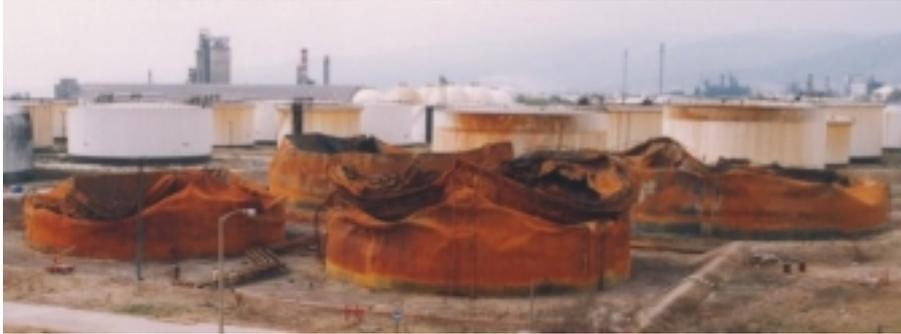
Figure 32. Post-earthquake fire damaged tanks in Tupras petrochemical complex
