Boğaziçi University  
KANDILLI OBSERVATORY  
and  
EARTHQUAKE RESEARCH INSTITUTE

## VAN EARTHQUAKE ( $M_w=7.2$ )

### EVALUATION REPORT as of 28 October 2011

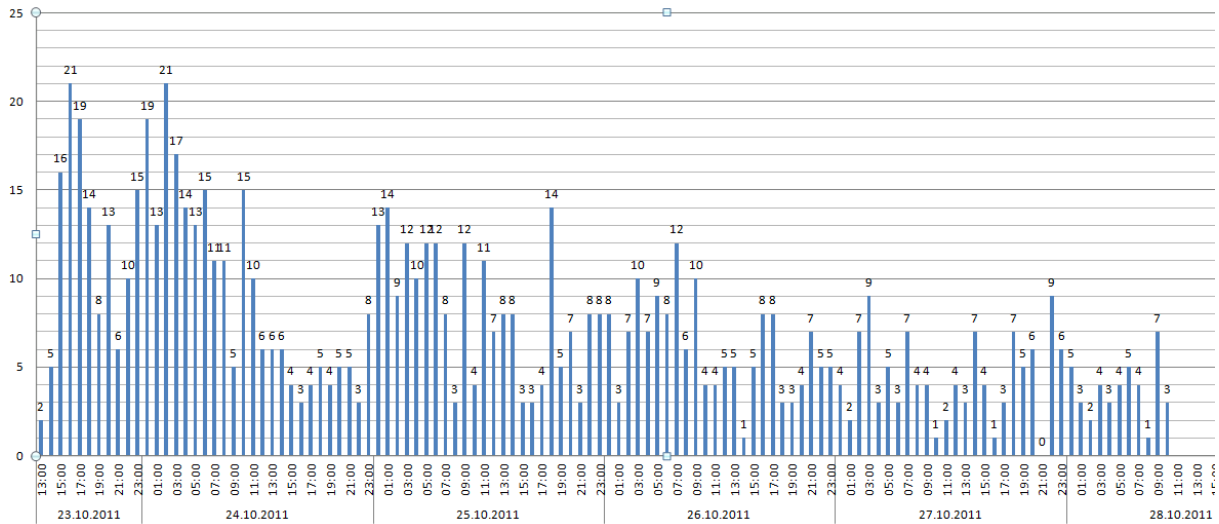
The figure above shows the hourly distribution of number of aftershock occurrences.

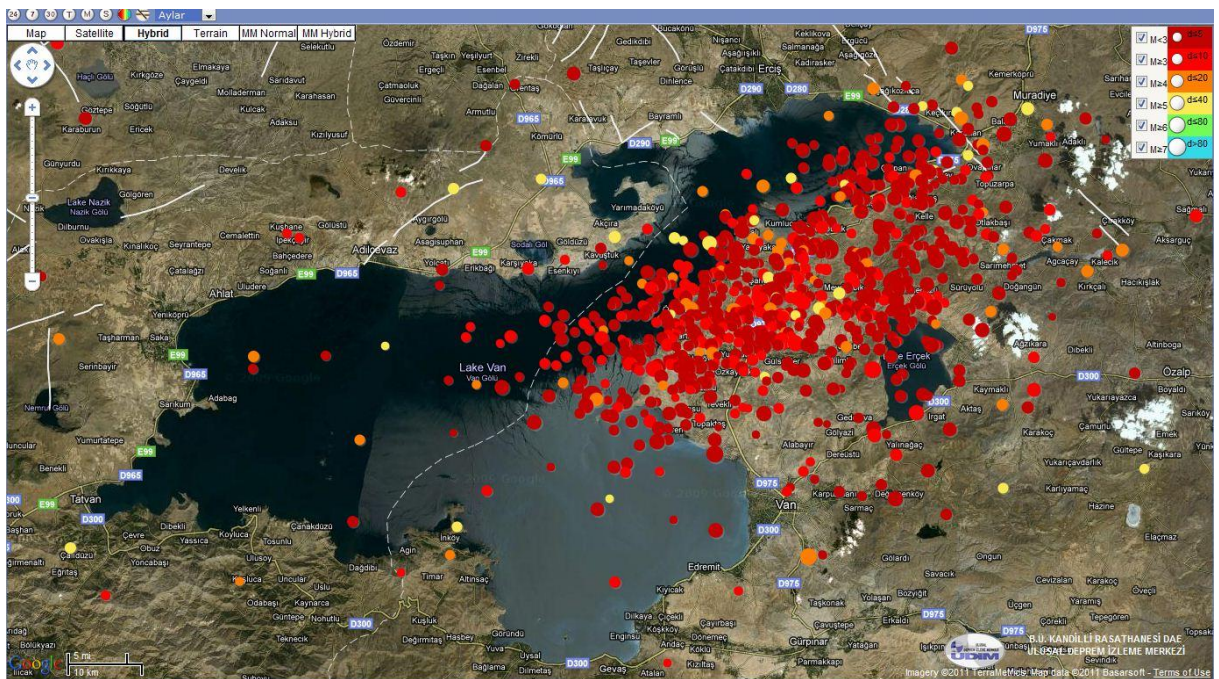
Distribution of aftershock sequences as of 28 October 2011 10:30 local time.
