EARTHQUAKE REPORT

24 MAY 2014 NORTHERN AEGEAN SEA

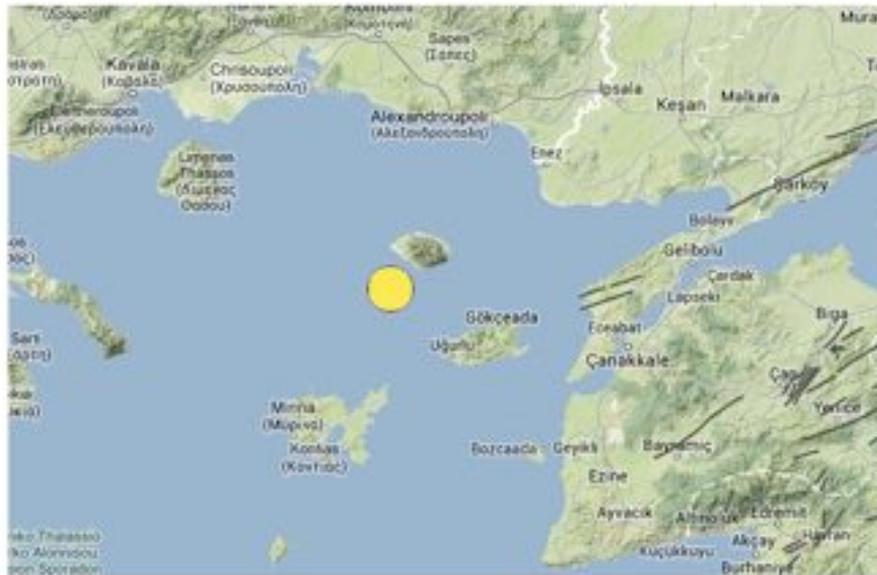
Figure 1-1. Epicentral location of the Offshore Gökçeada (Imbros) – Northern Aegean Sea Earthquake ($M_I=6.5$)

An earthquake with $M_I=6.5$ occurred in the Northern Aegean on 24 May 2014 12:25 local time (UTC +3) approximately 30 km north-west of Gökçeada (Imbros) Island resulting in strong ground motion in the region. The focal depth of the earthquake is 23 km and considered as shallow. The earthquake has been felt in Marmara and Aegean regions of Turkey, primarily in Çanakkale, Balıkesir, Edirne and Istanbul.

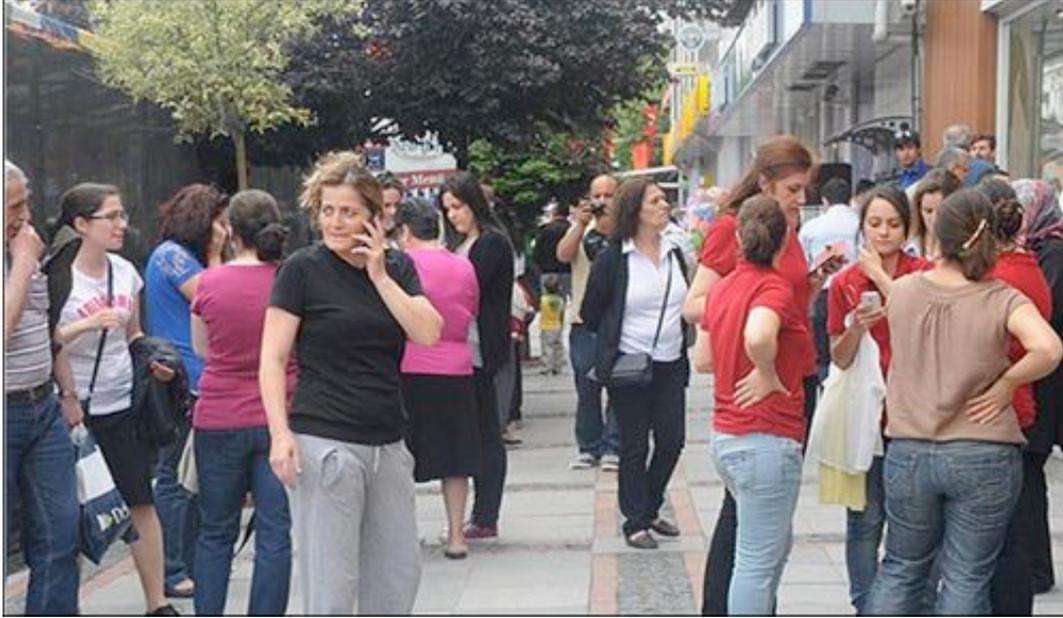
Figure 2-1. Residents of Edirne rushed to the street (After Cihan Haber Ajansı)

According to media reports, no major damage has been reported as a result of the earthquake, although hundreds of vulnerable buildings have sustained damage. Several hundred people in the region have been reported injured mostly the result of panic as people rushed out of buildings (Figure 2-1).

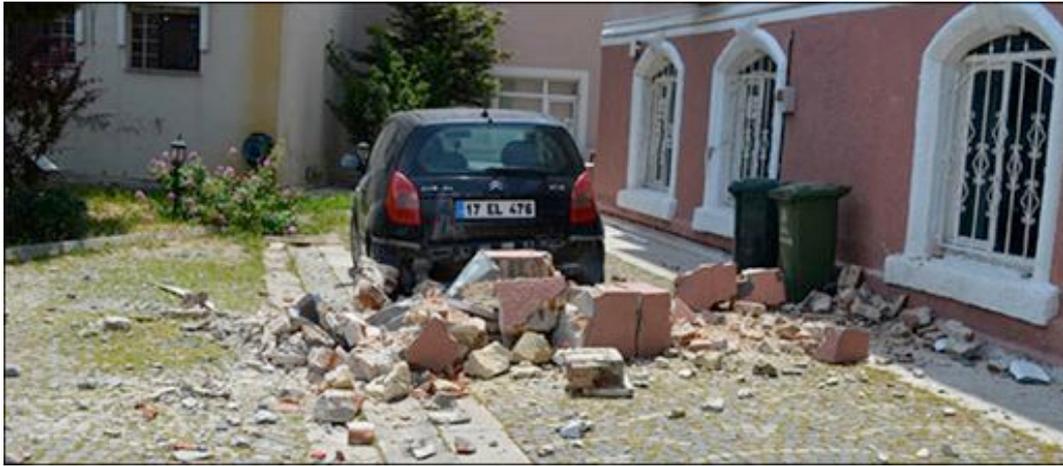
Figure 2-2. Damage at Gökçeada (After Doğan Haber Ajansı)

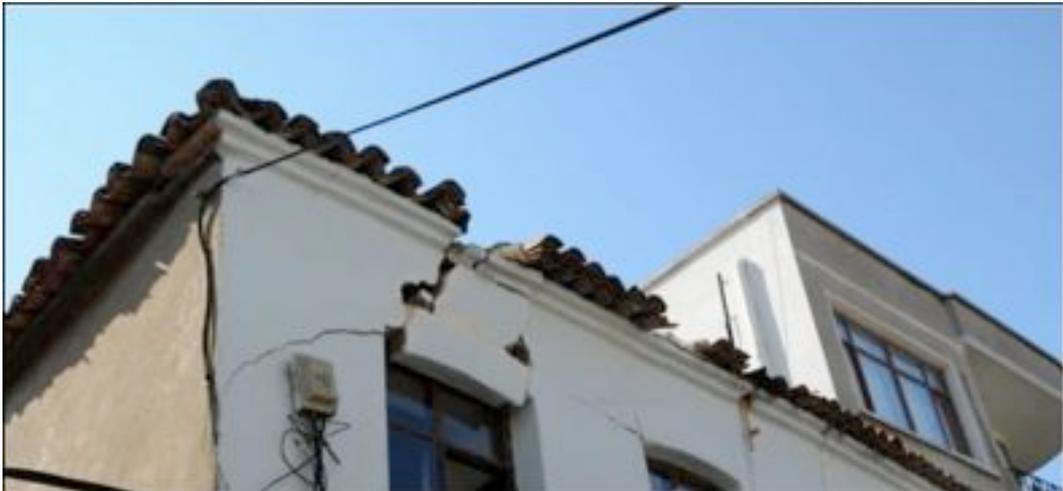
Figure 2-3. Damage to a Building at Gökçeada (After Haberciniz.biz)

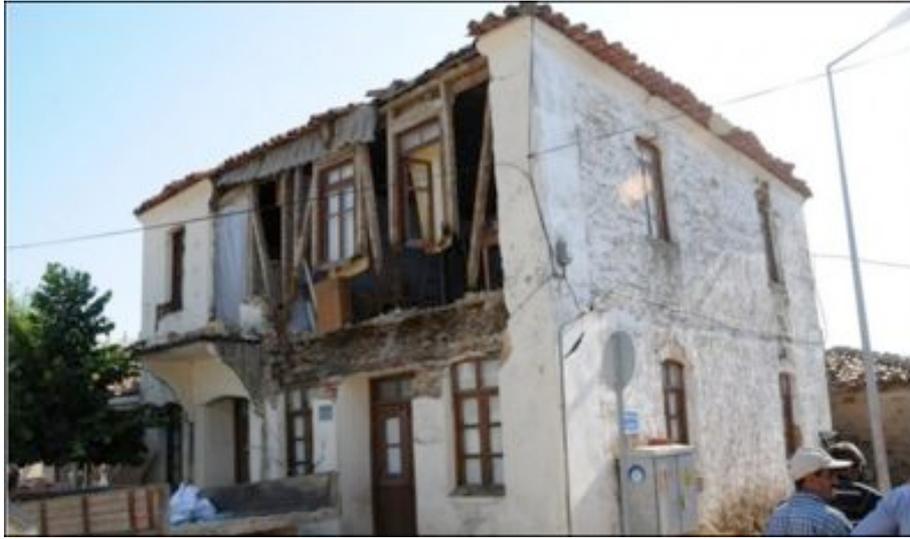
Figure 2-4. Damage to a Building at Gökçeada (After Haberciniz.biz)

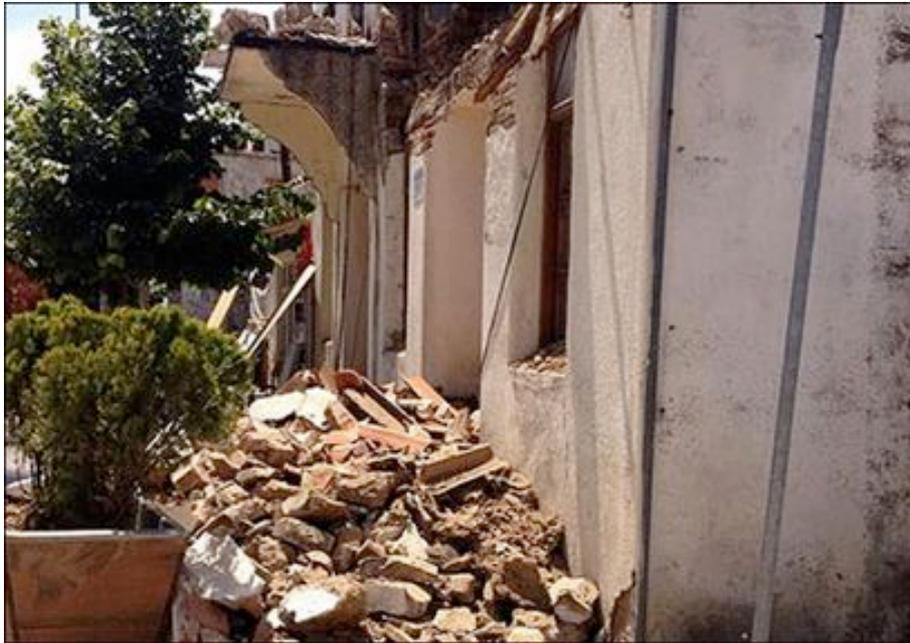
Figure 2-5. Damaged Building in a Çanakkale (After Cihan Haber Ajansı)

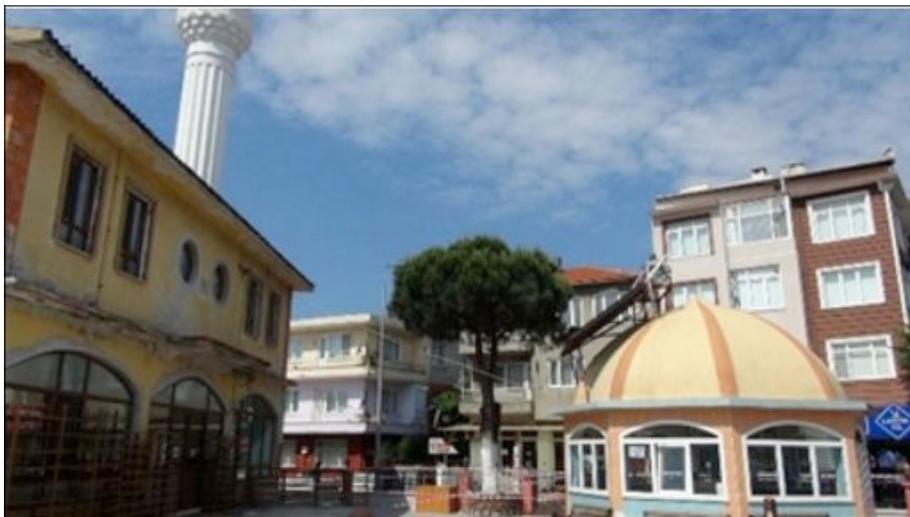
Figure 2-6. Minor Damage at Aslanca Mosque in Çanakkale (İhlas Haber Ajansı)

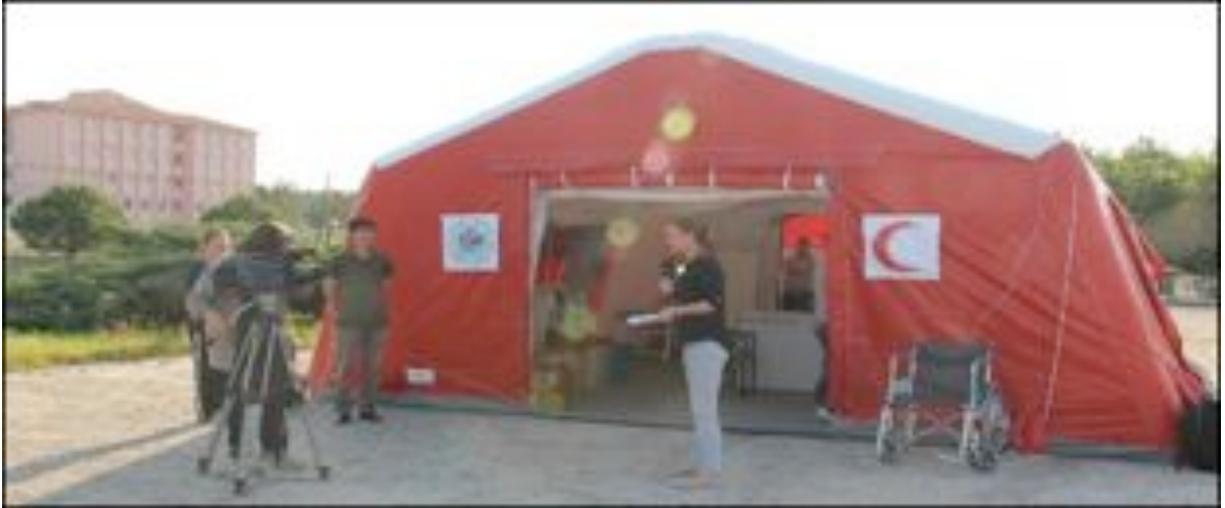
As reported by the Disaster and Emergency Management Presidency (AFAD), about 321 people were temporarily hospitalised, most with minor injuries. Most of the injuries were caused by people panicking during the earthquake and rushing out of their homes and even jumping from the balconies. AFAD reported that: in Çanakkale province the earthquake caused damage to about 300 buildings, about 50 of them located in the city of Çanakkale and 200 of them located in the island of Gökçeada (Figures 2-2, 2-3, 2-4 and 2-5). There were 8 school buildings with light damage. According to media reports, in the city center of Çanakkale three mosques received light damage mostly in the top of the minarets. Among those the Arslanca Mosque was closed to prayers, pending further assessment of damage (Figure 2-6). Furthermore, the earthquake caused cracking in the walls of Yenice state hospital in the province of Çanakkale. The patients were evacuated from the hospital, and a field hospital was constructed (Figure 2-7).

Figure 2-7. Lighty Damaged Hospital building and the field hospital installed

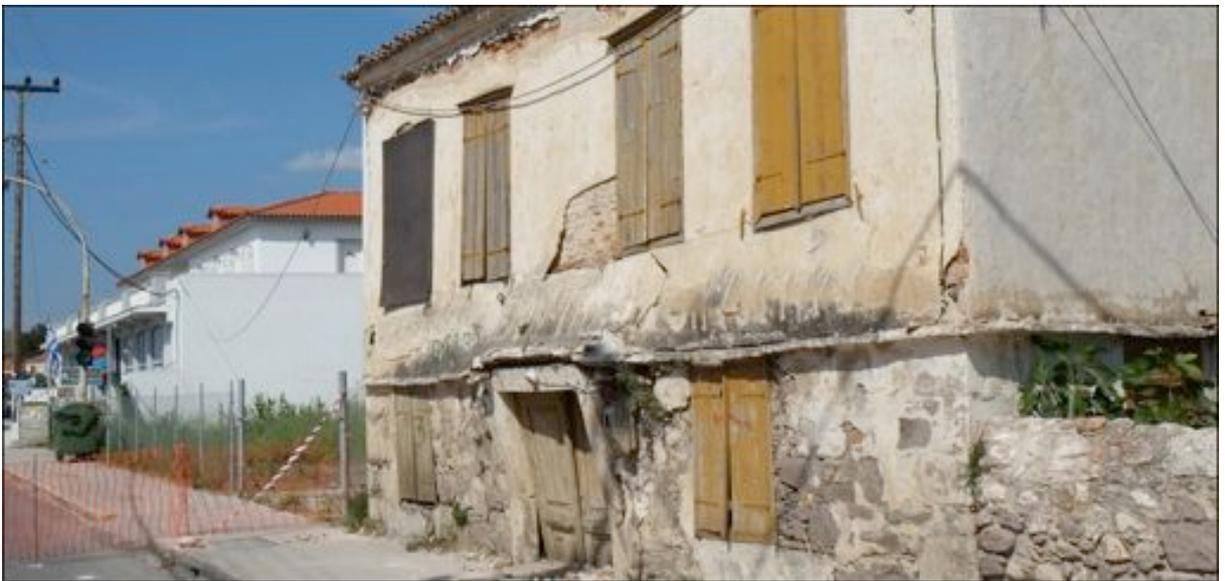
In the island of Lemnos, according to media reports, the earthquake caused the collapse of 11 uninhabited houses, two churches were damaged while there were minor damages in tens of houses and three schools. Significant damages have been recorded in the Myrina museum where dozens of exhibits fell on the floor. There was damage to the suspended ceiling of the Lemnos Airport (Figure 2-9).

Figure 2-8. Damage to an old building in Lemnos Island (*After Protothema News*)

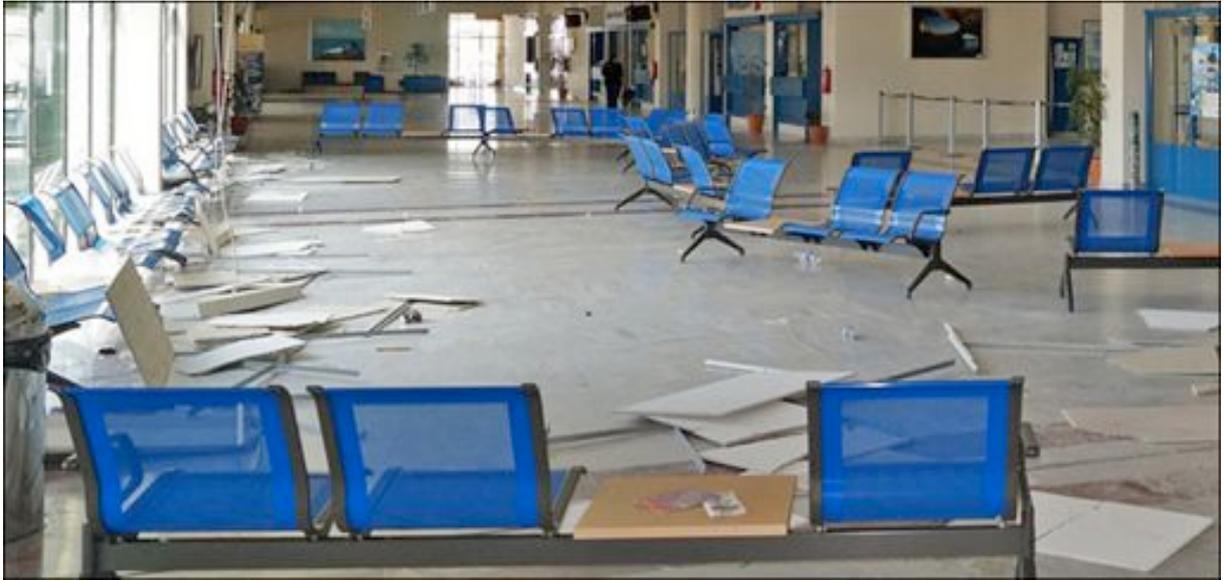
Figure 2-9. Suspended Ceiling Damage at Lemnos Airport (After Liz Fields (/contributor/liz-fields))

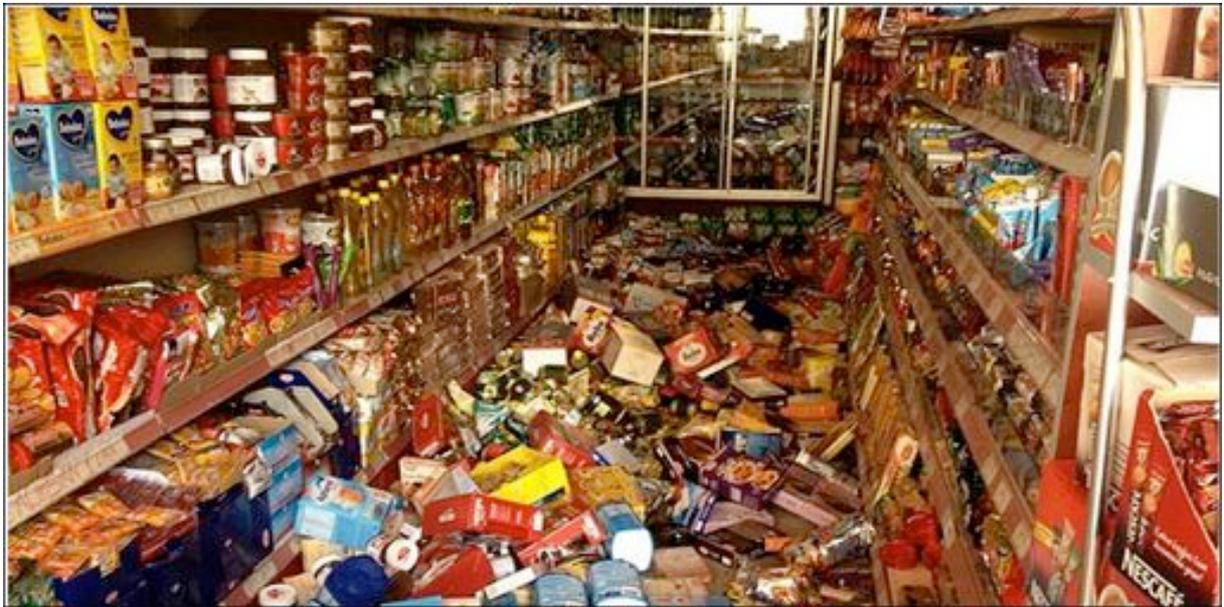
Contents damage was widely reported with objects falling from shelves in the region, some as far as 250km away (Figure 2-10).

Figure 2-10. Damage to shelved items in a Market in Adapazarı (about 250km east of the epicenter) (After Cihan Haber Ajansı)

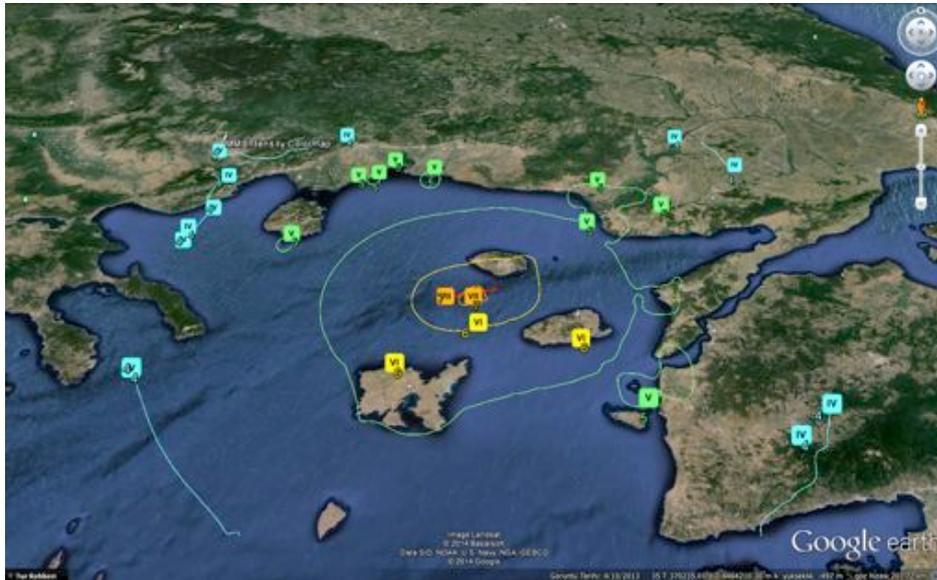
Figure 3-1. Near Real Time Intensity Map of the event by RT-ELER (www.kandilli.info).

ELER (Earthquake Loss Estimation Routine) has been utilized for the Earthquake Hazard and Loss estimation studies. After the event the RT-ELER has automatically produced the intensity map of the event as shown in Figure 3-1 (www.kandilli.info). As it is shown from the Figure 3-1, the first intensity estimation of the event was VII in the epicentral region, VI in the nearby islands and V, IV on the Greek and Turkish coasts.

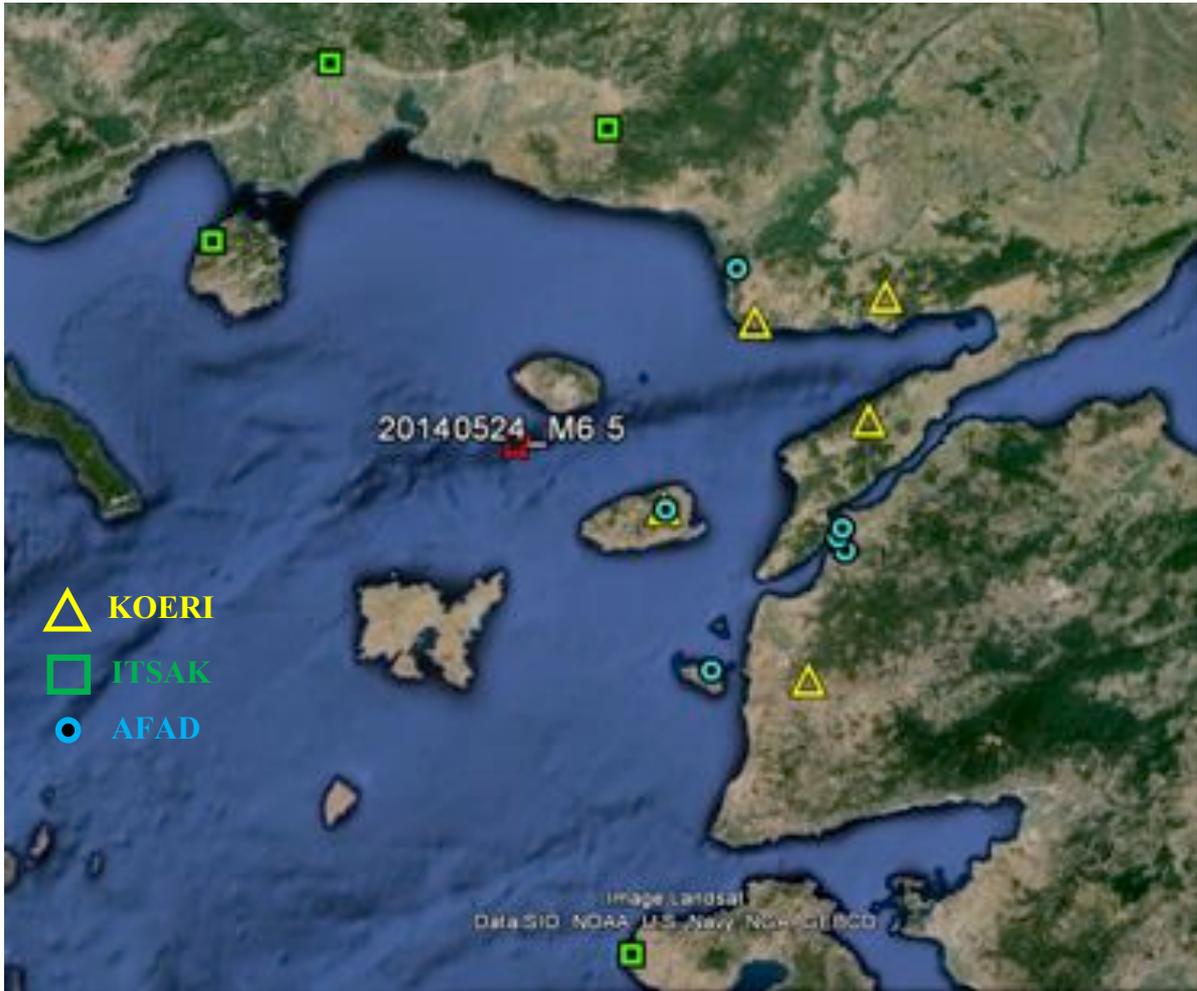
The raw PGA values recorded at the accelerometric stations from Greek (ITSK) and Turkish (KOERI and AFAD) networks with their distances to the epicenter are given in Table-1, and their locations are shown in Figure 3-2.

Figure 3-2. Location of Accelerometer Stations in the vicinity of the event with different networks.

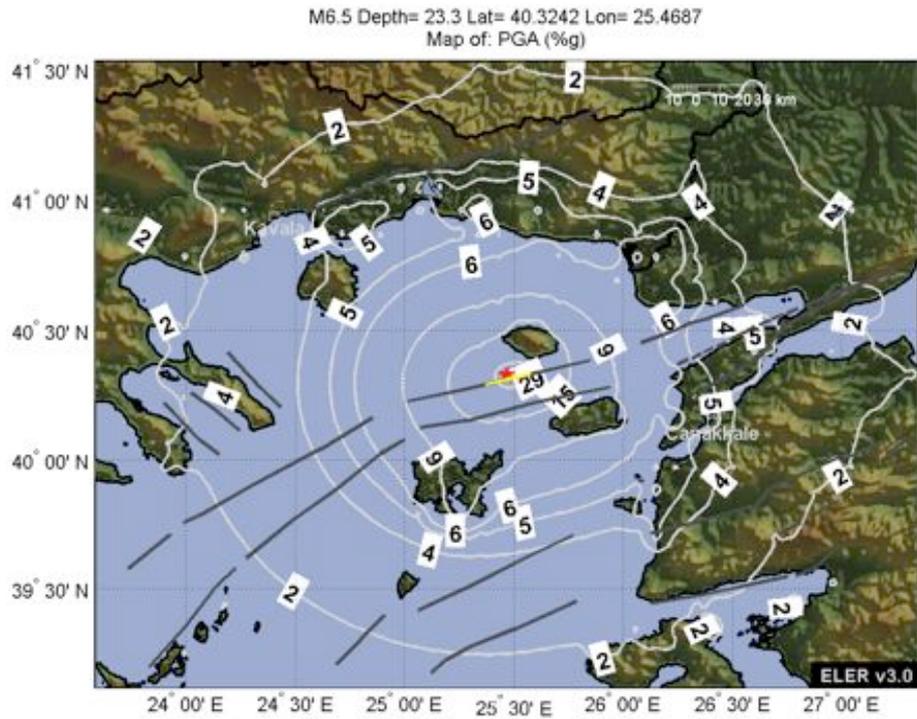
The first PGA distribution estimation of the event has been achieved by RT-ELER without any station information as shown in Figure 3-3. Boore-Atkinson (2008) ground motion prediction equation has been used for this first estimation. The estimated PGA distribution has been bias-adjusted after the information from acceleration networks KOERI, ITSAK and AFAD were obtained. Figure 3-4, Figure 3-5 and Figure 3-6 show the bias adjusted PGA distribution with the information from KOERI, ITSAK and AFAD accelerometric networks.

Figure 3-3. PGA distribution without station information.

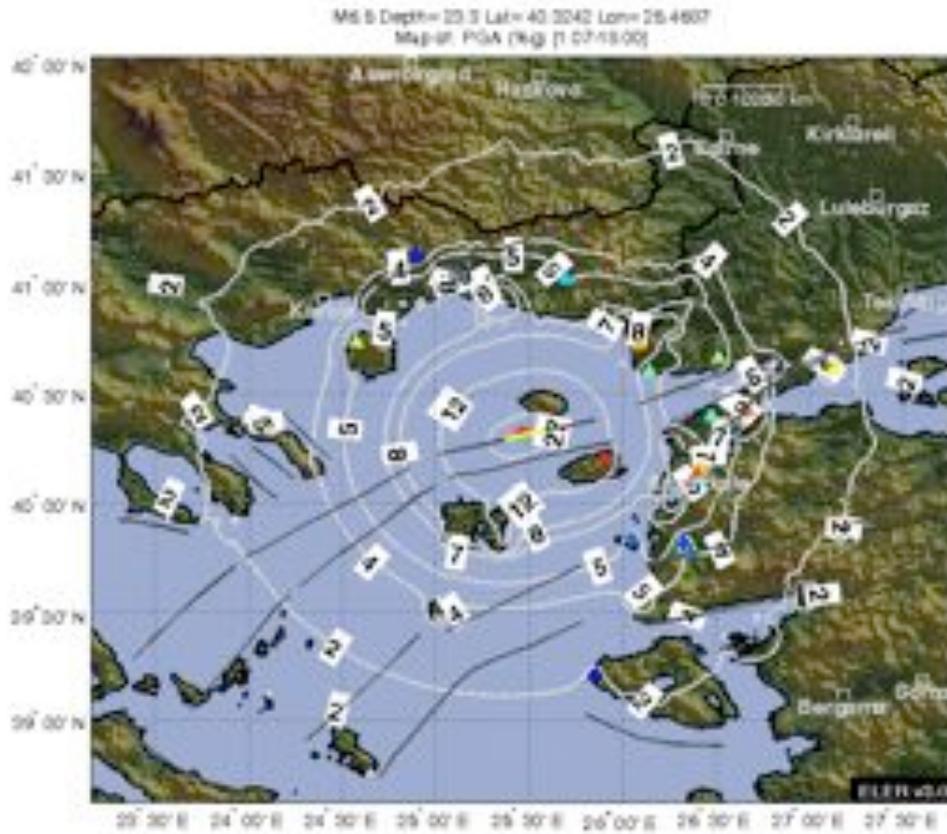
Figure 3-6. PGA distribution with information from ITSAK, KOERI and AFAD networks.

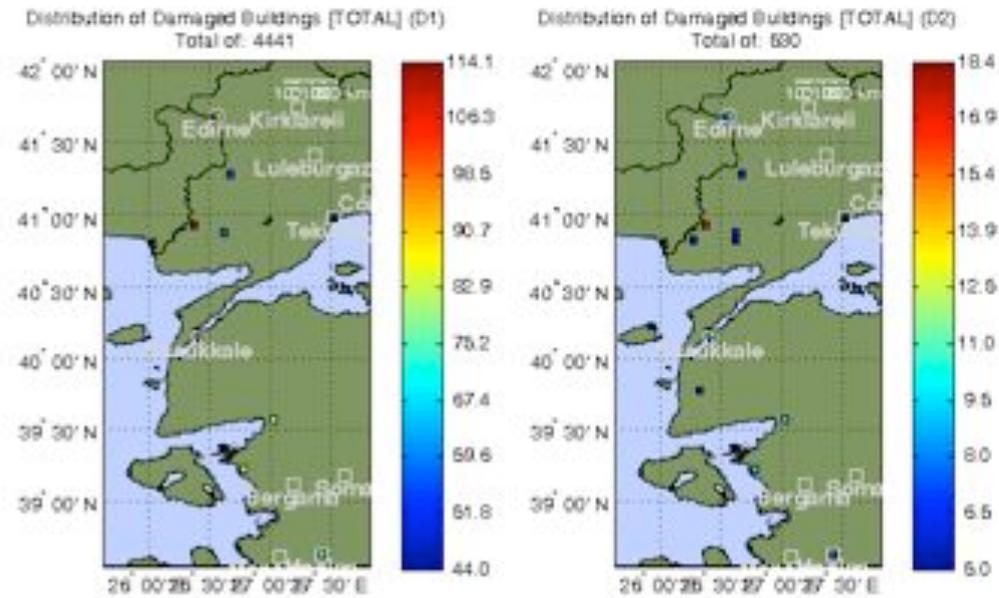
Figure 3-9. Number of Buildings with D1 (Slight Damage) and D2 (Moderate Damage) Levels on the left and right sides, respectively.

The intensity based empirical vulnerability relationship has been used for the building damage estimation in the epicentral region for the Damage Levels D1 to D5 from Slight Damage to Destruction as shown from Figure 3-9 to Figure 3-10.

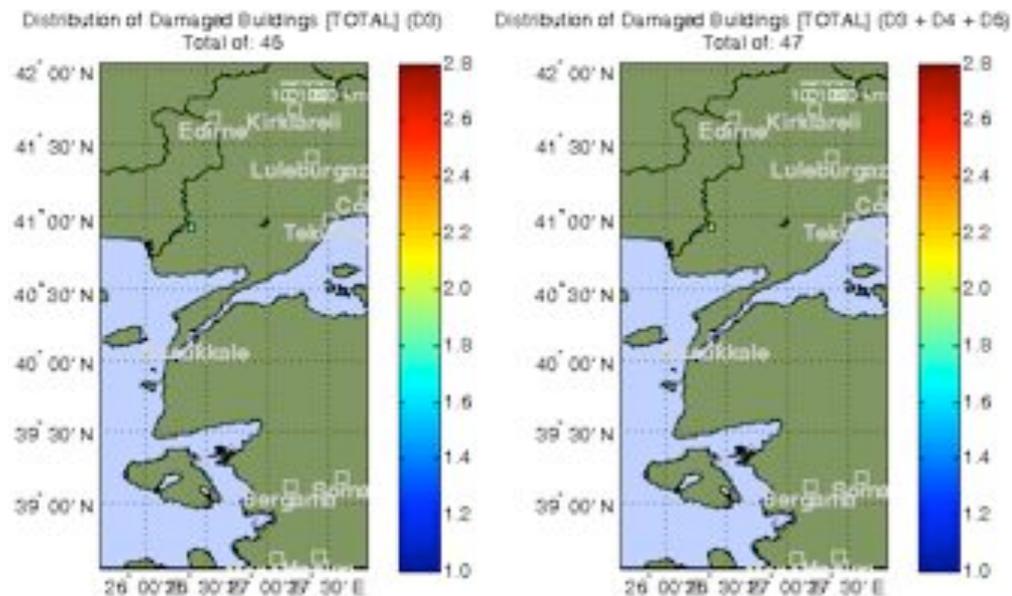
Figure 3-10. Number of Buildings with D3 (Substantial to Heavy Damage) and D3+D4+D5 (Substantial to Heavy Damage+Very Heavy Damage+Destruction) Levels on the left and right sides, respectively.

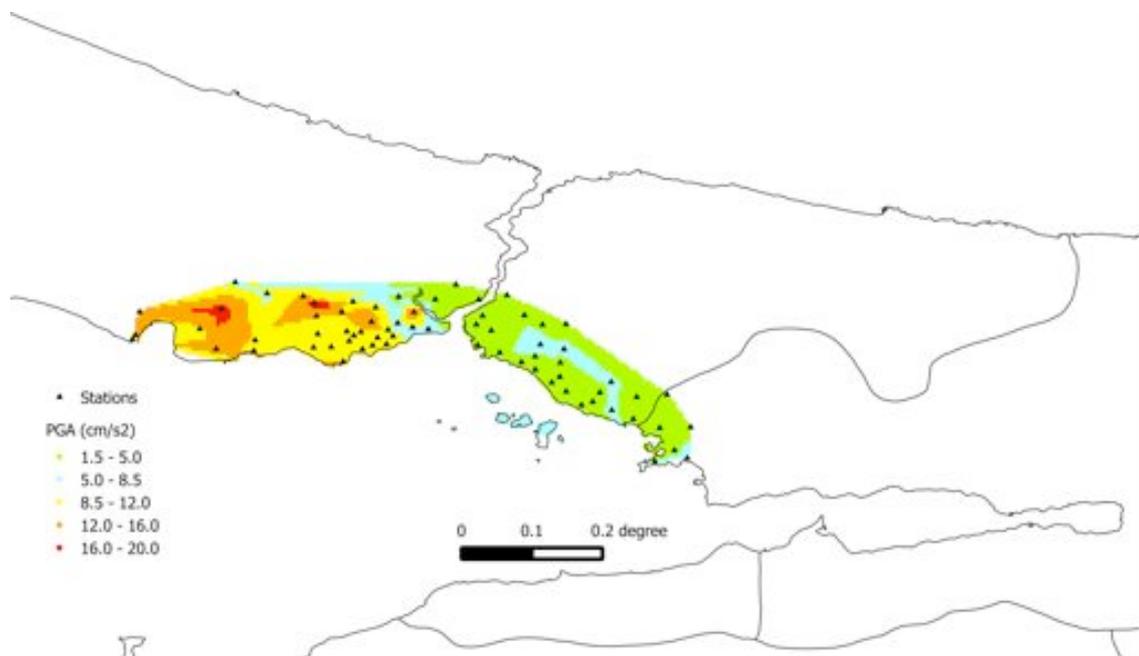
Figure 4-1. PGA (cm/s^2) distribution map of the Istanbul area obtained from Istanbul Early Warning and Rapid Response Networks

Rapid Response and Early Warning networks operated by KOERI recorded a total of 75 accelerograms from the 24 May 2014 Aegean Sea, earthquake. The accelerograms were uniformly processed by applying band-pass acausal filtering. The low-pass and high-pass filter cut-offs were determined individually for each component. Figures 4-1 to 4-4 show the distributions of horizontal peak ground acceleration (PGA), peak ground velocity (PGV) as well as 5%-damped pseudo spectral accelerations (PSA) at $T = 0.2s$ and $T = 1.0s$. The distributions display the geometric means of considered ground-motion intensity measures. The maps given in these figures indicate that the mainshock PGA and PGV variations over the Istanbul area are between $1.5 \text{ cm/s}^2 < \text{PGA} < 20 \text{ cm/s}^2$ (Figure 4-1) and $0.6 \text{ cm/s} < \text{PGV} < 4 \text{ cm/s}$ (Figure 4-2), respectively. The distributions of PSA at $T = 0.2s$ and $T = 1.0s$ take values between $3 \text{ cm/s}^2 - 40 \text{ cm/s}^2$ (Figure 4-3) and $2 \text{ cm/s}^2 - 42.5 \text{ cm/s}^2$ (Figure 4-4), respectively. The observed mainshock peak ground motion and spectral amplitudes mapped for the Istanbul city are low as the source-to-site distances between the mainshock and sites are large. For this reason, the likelihood of structural damage in Istanbul due to the 24 May 2014 Aegean Sea, earthquake is negligible. The ground-motion amplitudes shown in Figures 4-1 to 5-4 tend to decrease towards stiffer sites. The amplitude distributions of PGV (Figure 4-2) and PSA at $T = 1.0s$ (Figure 4-4) mark this observation better. The observed large-amplitude pockets on the maps may bring forward the effects of local site and topography on the recorded ground motions. The maximum horizontal component PGA distribution recorded from the entire earthquake affected area that is given in Figure 4-5 indicates a measured PGA value of 65.7 mg at Mecidiye-Edirne. The distribution of maximum horizontal component PGA for the Istanbul area is given in Figure 4-6.

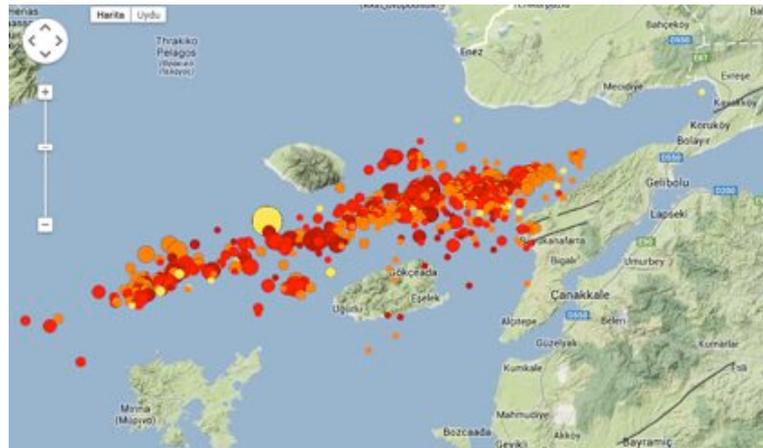
The most prominent feature of the earthquake is the widespread distribution of the aftershocks. The routine fast locations carried out by the National Earthquake Monitoring Center (NEMC) of KOERI portrays a lateral variation of longitudes between 25.0°E and 26.2°E . This corresponds to approximately 120 km fault rupture length if all the aftershocks take place along the

Figure 5-1. The aftershock distribution of events between May 24th and May 30th, 2014.

ruptured fault plane. Using the USGS estimated seismic moment magnitude of $M_w=6.9$ and the relation between fault rupture length and moment magnitude of Wells and Coppersmith (1994), $(\text{Log}(L)=(M_w-5.16 \pm 0.13)/1.12 \pm 0.08)$ yields a rupture length between 35-60 km. Thus estimated rupture length is a few times shorter than the rupture derived from the aftershock distribution (Figure 5-1).

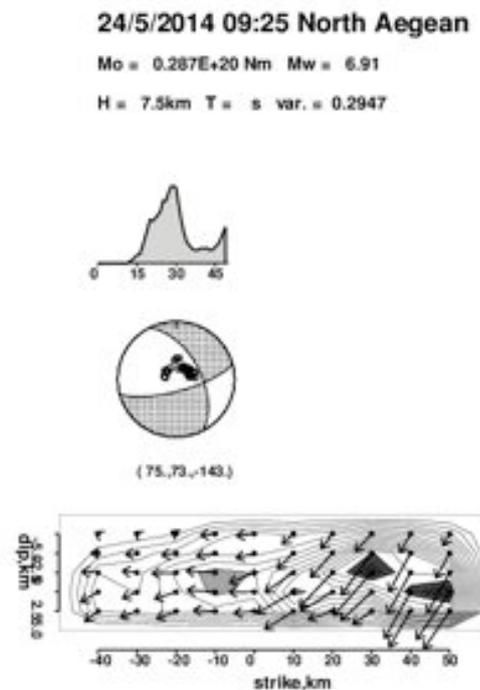
Using the complex teleseismic bodywave records generated by the earthquake and the method developed by Kikuchi and Kanamori (2003) we estimated the seismic moment release on each subfault grid distributed along the strike and dip of the ruptured fault plane (Figure 5-2). The grid size of 10x5 km was chosen as 10 km along the strike and 5 km along the dip of the fault plane. The inversion results yield a seismic moment of $M_0=2.9 \times 10^{19}$ Nm ($M_w=6.9$) and approximately 30 sec source rupture duration. The size and arrow of the vectors (rake) shown on the fault plane (Figure 5-2) characterize the seismic moment tensor derived for each grid point. The rakes illustrated in Figure 5-2 suggests that the region to the west of the epicenter experienced mainly strike-slip motion while to the east considerable dip-slip component contributed to the motion on the fault plane.

Figure 5-2. 2D slip distribution along the ruptured fault plane.

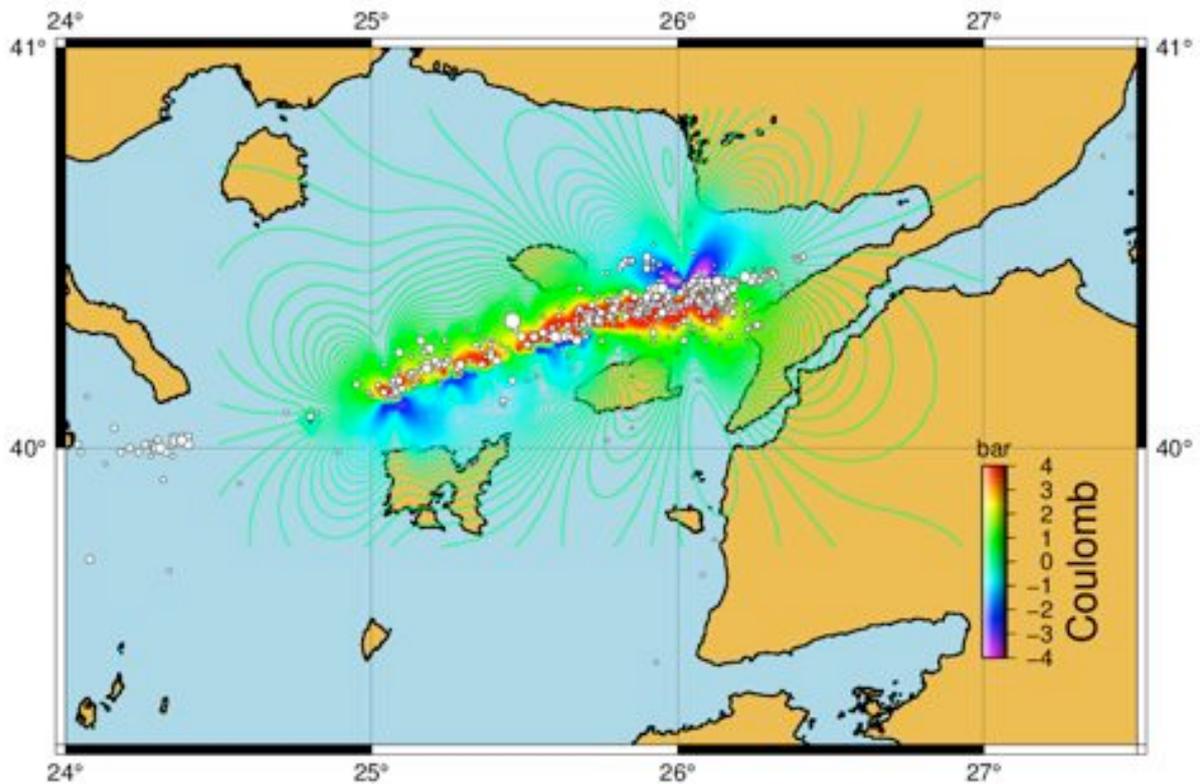
The slip distribution model portrayed in Figure 5-2 was used to estimate the co-seismic static stress changes associated with the mainshock. In our calculations we used a frictional coefficient of 0.3 which is one of the parameters affecting the spatial distribution of the Coulomb stress changes for the optimally oriented fault planes. Considering the predominantly strike slip mechanism for most of the events in North Aegean we used a regional stress tensor appropriate for strike-slip tectonic regimes. The azimuth of the maximum principle axis was fixed at 290 degree. The results with the fixed parameters are shown in Figure 5-3. Here, the red colour indicates the areas of increased stress changes and the blue regions show the region where the stress changes are negative.

Figure 5-3. Coulomb stress changes associated with the mainshock. The aftershocks tend to take place at regions of increased stress. Note the southward extension of the aftershock area and the area of increased stress to the east of the epicenter where dip-slip component was derived.

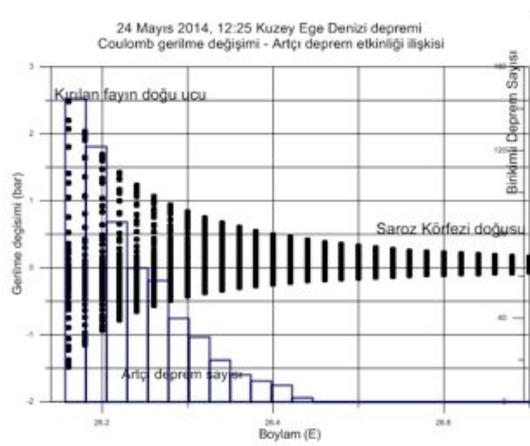
We constructed an east-west cross-section of the Coulomb stress changes based on the results presented in Figure 5-3 so as to explore the eastward extension of the stress changes toward the Saros bay (Figure 5-4). Such a cross section reveals that the Coulomb stresses exponentially decrease starting from the eastern termination of the rupture toward the east. Besides, it is obvious from Figure 5-4 that the aftershocks taking place to the east of the mainshock area are the events triggered by the static stress increase rather than events taking place on a ruptured plane. Most of the aftershocks concentrate at the region where the stress increase is between 0.5-3.0 bars. The region where the stress is less than 0.5 bar the aftershock activity diminishes.

Figure 5-4. A relation between the number of aftershocks and the stress changes to the east of the ruptured plane (the black dots are the stresses and the histogram show the number of the aftershocks).

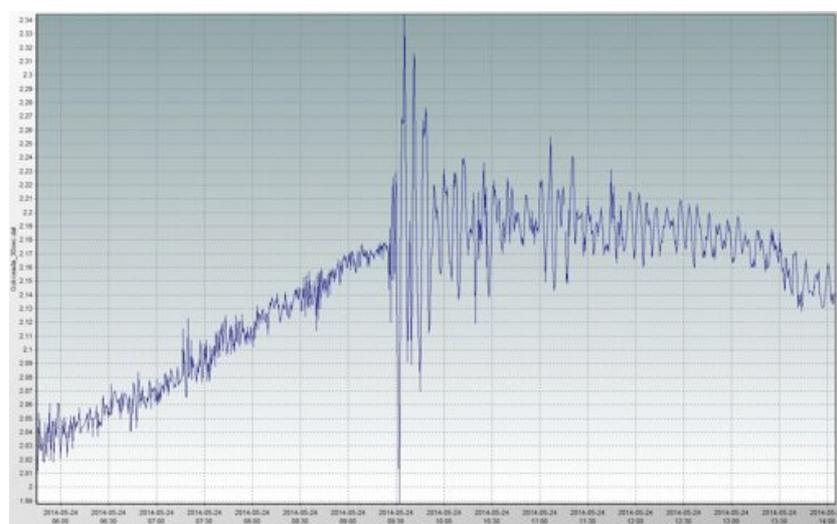
Figure 7-2. Sea-level record indicating a 16 cm tsunami at Gökçeada (Imbros) tide-gauge station in Turkey (measured relative to the normal sea level as indicated in the ICG/NEAMTWS Interim Operational User's Guide).
