## The October 23, 2011 Van, Turkey Earthquake ( $M_w=7.2$ )

### EARTHQUAKE DAMAGE

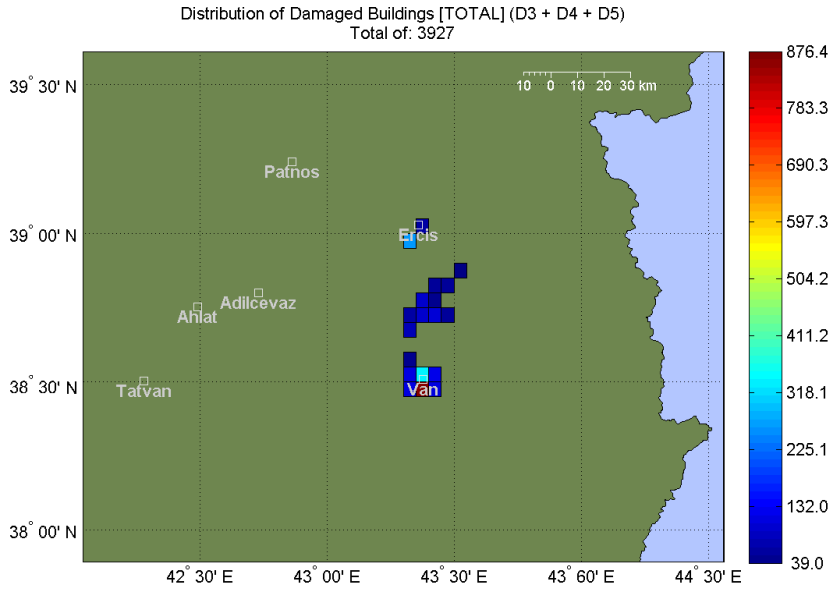
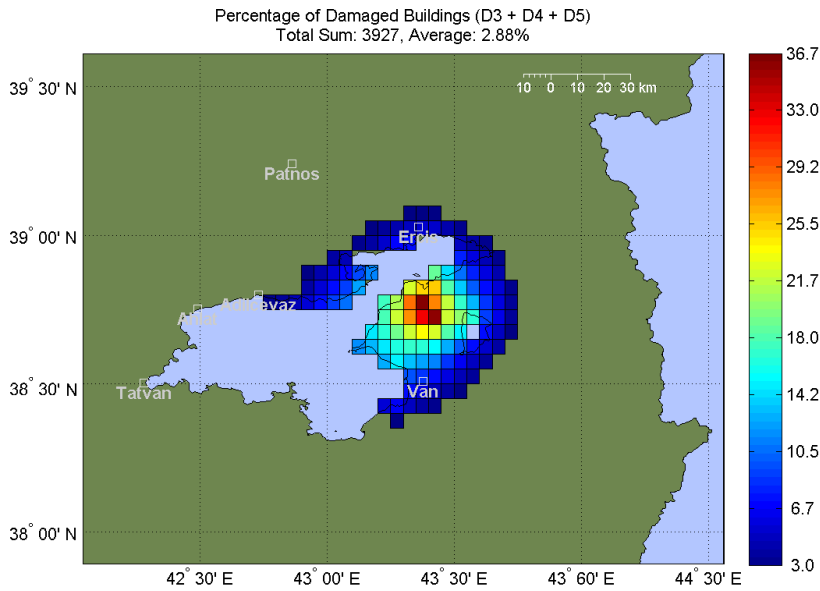
In Figures 4 and 5, building damages as estimated by software ELER (Earthquake Loss Estimation Routine) are presented. Figure 4 shows grid based, D3+D4+D5 (substantial to heavy damage+very heavy damage+destruction) type damages in the region. It is estimated that 3927 buildings may have received that type of damage (Figure 4, top). The largest damage of this type is estimated in grid cells located in Van city center. In Figure 4 (bottom), percentage of estimated buildings in damage state D3+D4+D5 over the total number of buildings in each grid cell is shown. Figure 5 shows etimated, grid based, D1+D2 (slight damage+moderate damage) type damages in the region. It is estimated that 34537 buildings may have received slight or moderate damage. The distribution of the number of buildings in this damage state is given in Figure 5 (top). The percentage of this number to the total number of buildings in each grid cell is given in Figure 5 (bottom). From these figures it can be concluded that a higher portion of the building stock is expected to be in less critical damage states.

Figure 4. Building damages estimated by ELER, damage type D3+D4+D5. The number of damaged buildings in each grid is shown in the top figure. In the bottom figure grid based percentages of damaged buildings are presented.

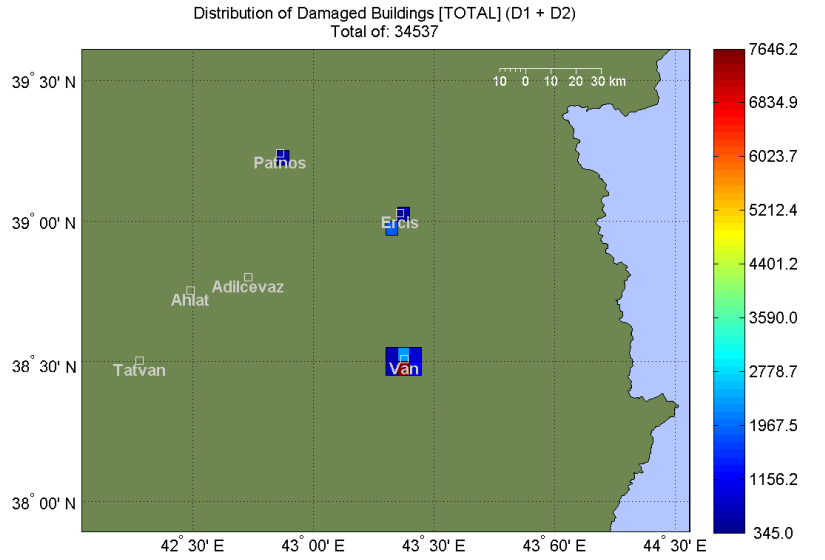
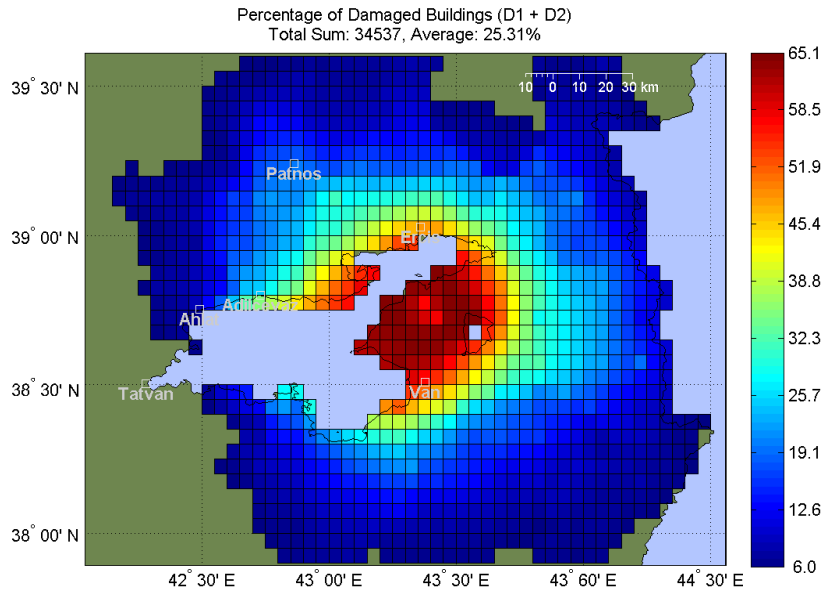
Figure 5. Building damages estimated by ELER, damage type D1+D2. The number of damaged buildings in each grid is shown in the top figure. In the bottom figure grid based percentages of damaged buildings are presented.
