REPORT ON 1999 KOCAELI AND DÜZCE (TURKEY) EARTHQUAKES

MUSTAFA ERDIK

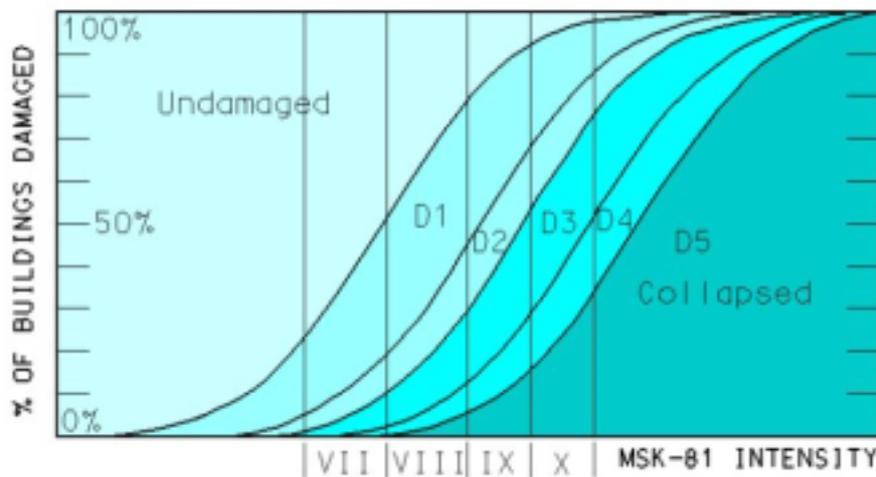
Figure 19. Earthquake vulnerability relationship for general mid-rise R/C buildings in Turkey

Intensity IX+ regions. This ratio is at least 4 times higher than what was observed in 1995 Kobe and 12 times higher than 1994 Northridge earthquakes. The general vulnerability relationship for mid-rise R/C frame buildings in Turkey is provided in Figure 19, where damages grades are indicated from D1 (slight) to D5 (collapse) following the EMS (European Macroseismic Scale) terminology.

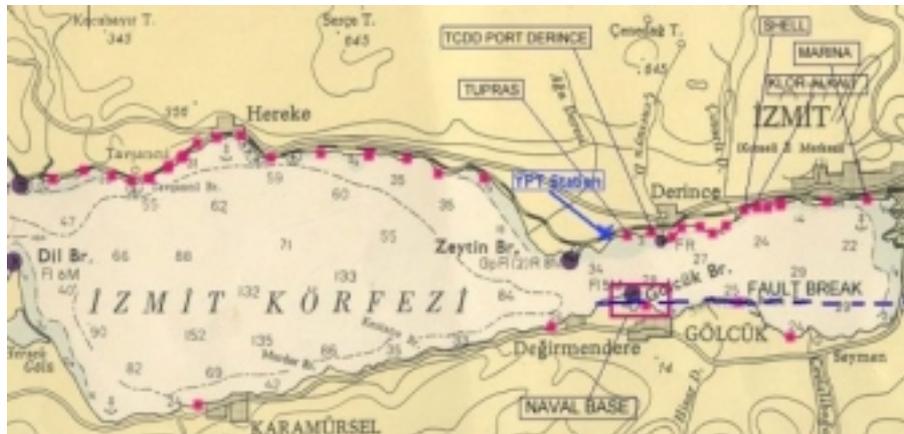
Figure 28. Location of affected ports and jetties in Izmit Gulf in the the Kocaeli Earthquake

Most of the ports and jetties privately operated by industrial facilities in Izmit Bay sustained damage (Figure 28). Extensive damage was observed at Golcuk Navy Base due to fault crossings (Figure 29). Damage included failure of piers, mechanical equipment, piping and the collapse of cranes. The government owned Derince general cargo and grain port, which handles some 2 million tons of cargo annually, suffered heavy damage to docks, cranes and warehouses, including cracks and severe subsidence. Deince Port, which is of the concrete caisson type with shorefront length of about 1.5 km, shifted away from the wharf up to 0.7m horizontally and 1m vertically due to liquefaction-induced deformations, settlements and lateral spreading (Figure 30). Several rail mounted portal cranes and some old steel warehouses were damaged. A substantial number of the jetties at the industrial facilities were also damaged. These include Petkim facilities, Tupras Oil Refinery, Petrol Ofisi, Shell Oil, Trans Turk, Seka Paper Mill and UM Shipyard.
