**PRELIMINARY ANALYSIS OF DATA
FROM THE AFTERSHOCK DEPLOYMENT
IN VAN AND ERCİŞ , TURKEY**

M=5.6 VAN EARTHQUAKE ON 09/11/2011

**Department of Earthquake Engineering
Kandilli Observatory and Earthquake Research Institute
Bogazici University
Istanbul, Turkey**

November 2011

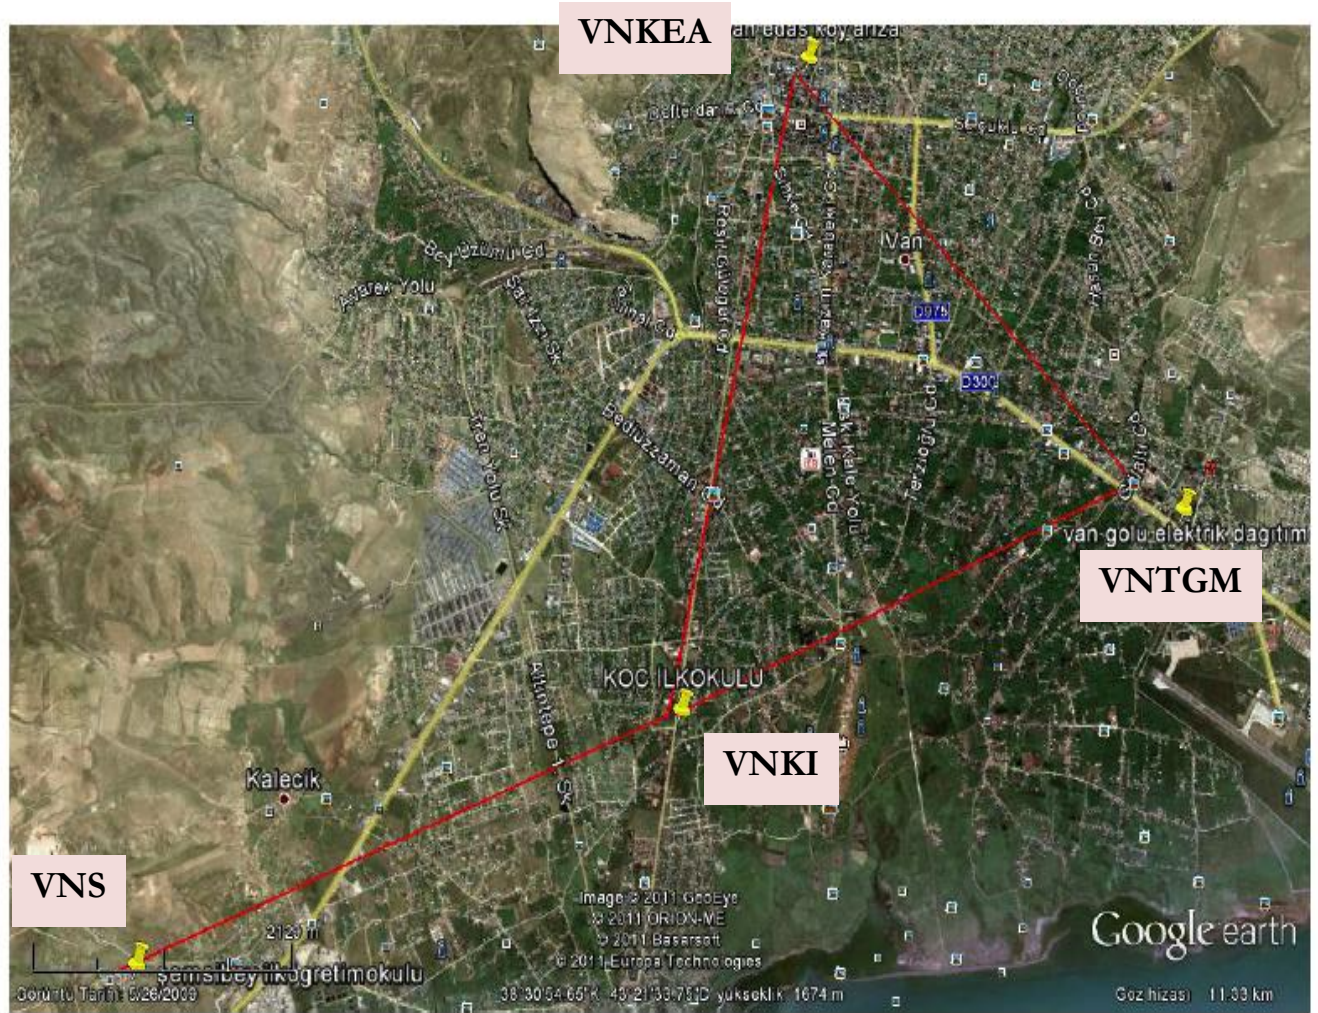
Figure 2. Locations of aftershock monitoring stations in Van

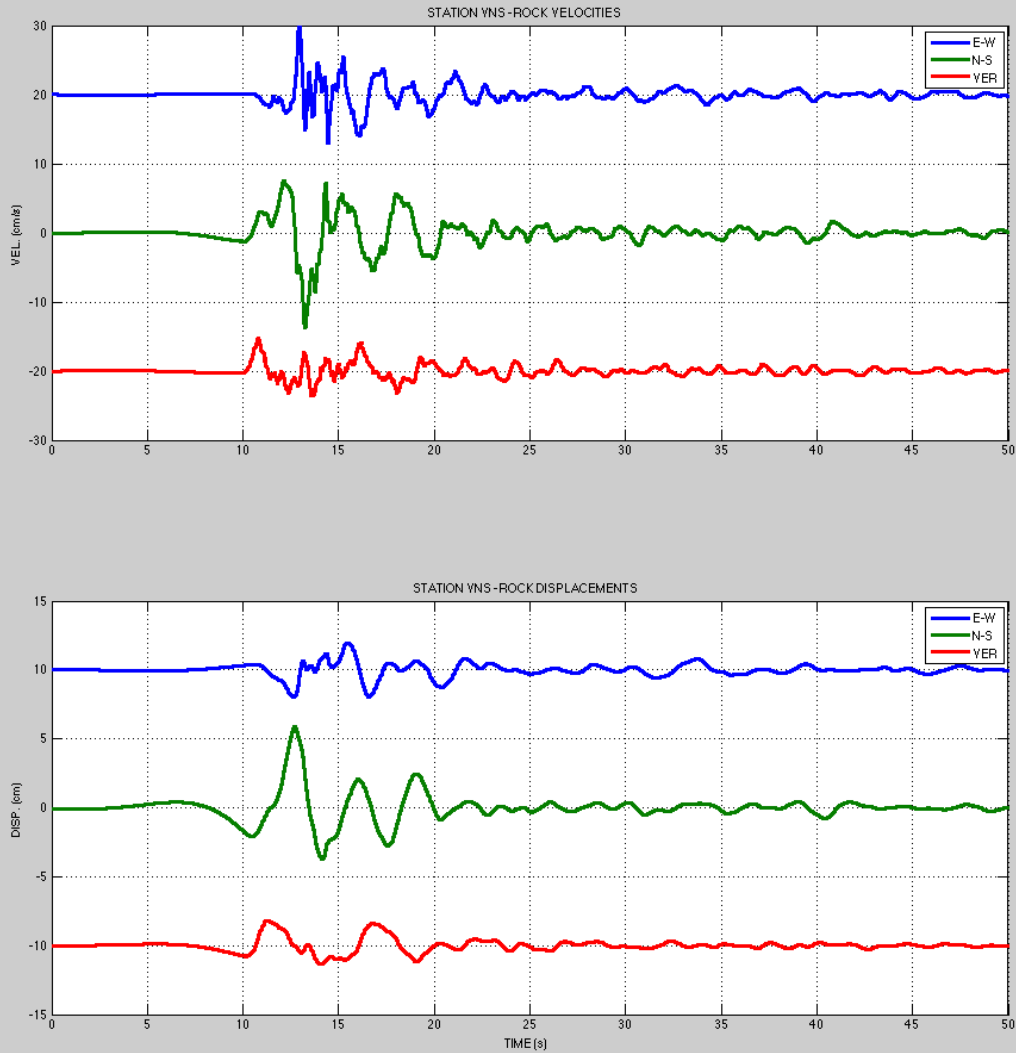
Figure 6. Velocities and displacements at station VNS (rock)
(Note: Rock site records need to be re-checked for accuracy)

We think that the records from the rock-site station in Van may have some calibration problems. So, although they are presented in the report, we do not recommend using them until further tests are done in the instruments. The other Van station that recorded the earthquake was very near the Bayram Hotel that was destroyed completely during this earthquake causing the deaths, among others, of several newsmen and a Japanese aid worker.

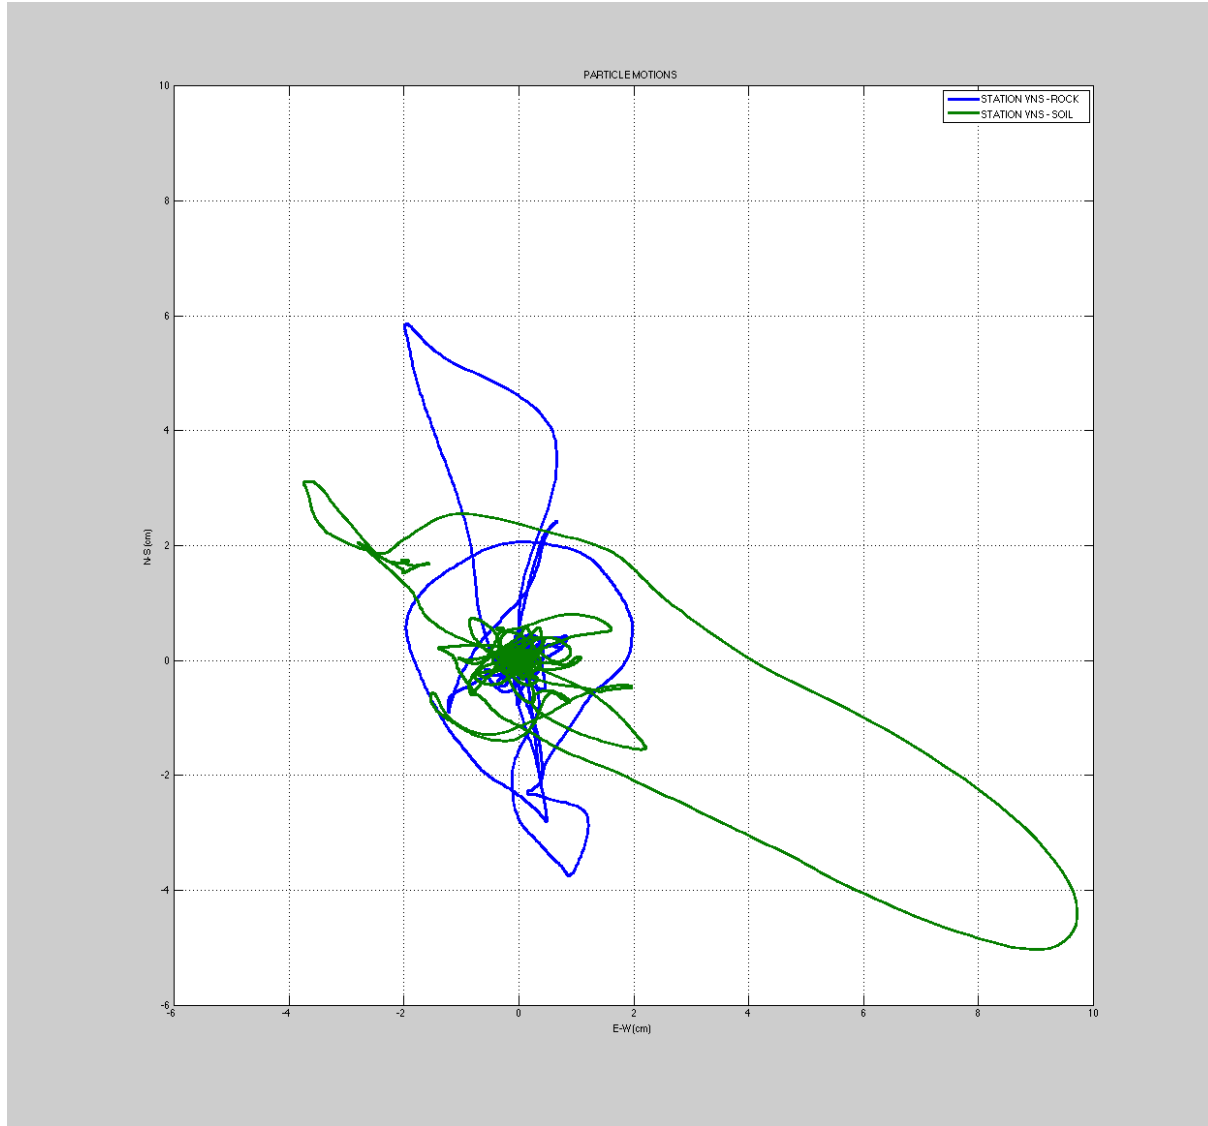
Figure 8. Particle motions at stations VNS (rock) AND VNKEA (soil)
(Note: Rock site records need to be re-checked for accuracy)

- There is a strong directionality in the particle motions of the Van records (Figure 8). It appears that the fault normal component is at about 120° N and the fault parallel component is at 30° N. This finding is in line with the fault mechanism solutions for this earthquake.

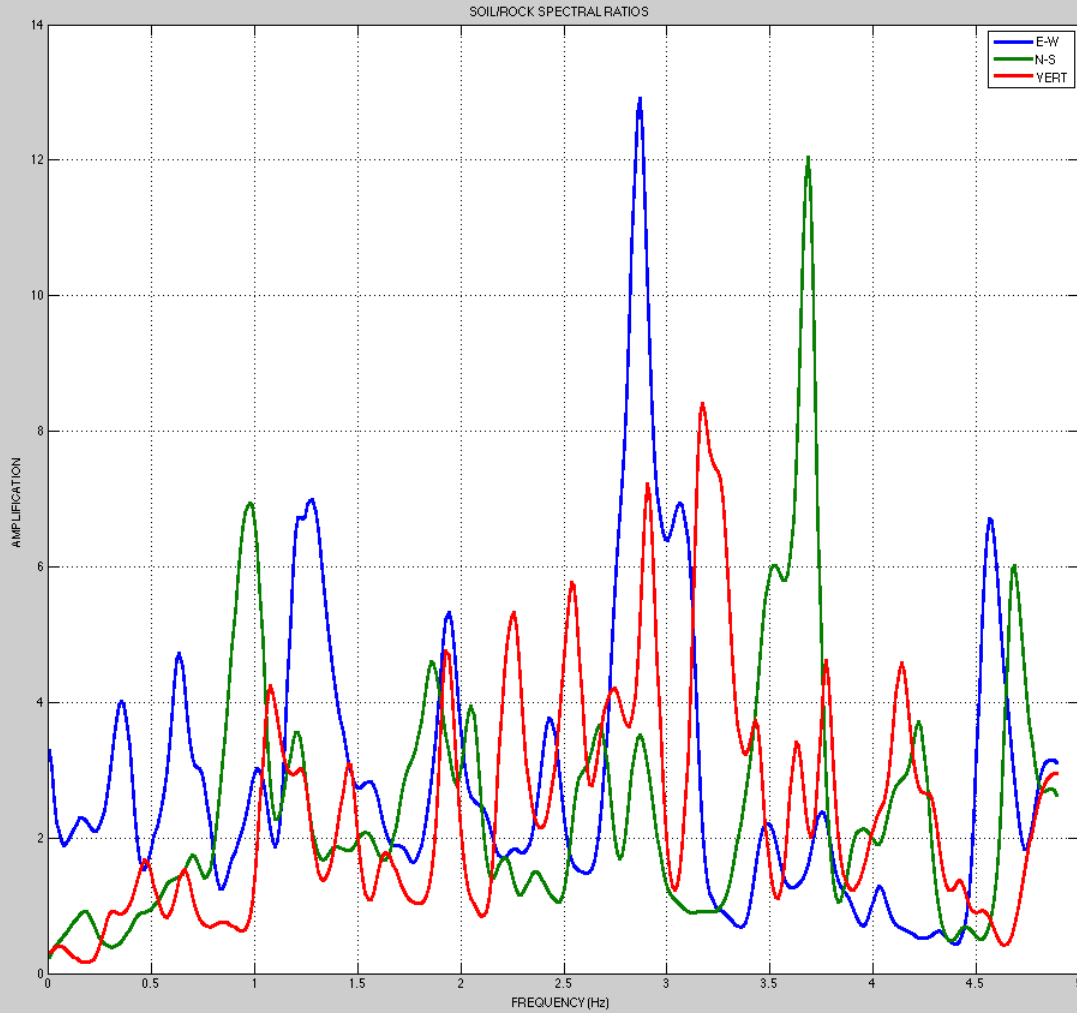
Figure 10. Soil (St. VNKEA) / Rock (St. VNS) spectral ratios
(Note: Rock site records need to be re-checked for accuracy)

- There are no distinct dominant frequencies in the spectral ratios (Figure 10) in Van that can suggest site effects. Yet in two frequency ranges, between 0.8-1.4 Hz and 2.6-3.8 Hz average amplifications reach 5 and 8 respectively.
